Lessons Learnt and Findings from BIRDS5-FTA

08/03/2023

BIRDS 5 Status

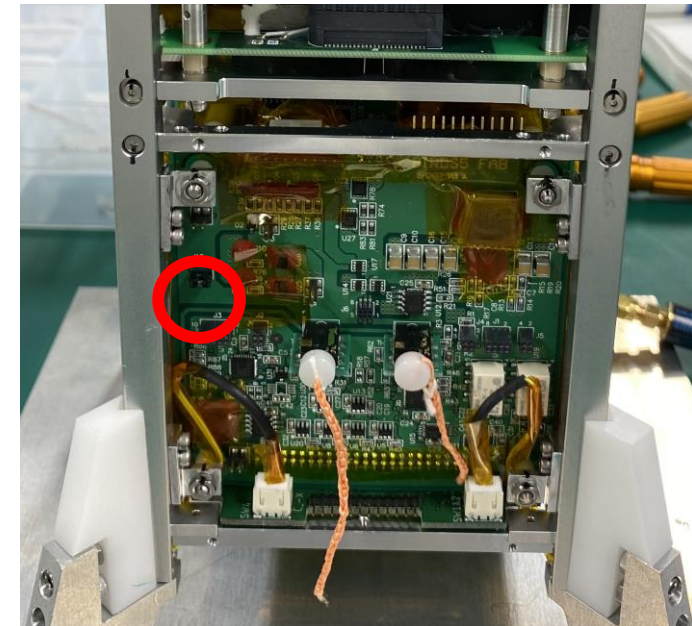
J15 highlighted

B. Jumper pins (J15) on the FAB dropped during vibration

- ❑ **Denied:**
 - ❑ Glued during assembly
 - ❑ After vibration the satellites functioned

- Solder Jumper pin (J15) on FAB
- Use rail switch

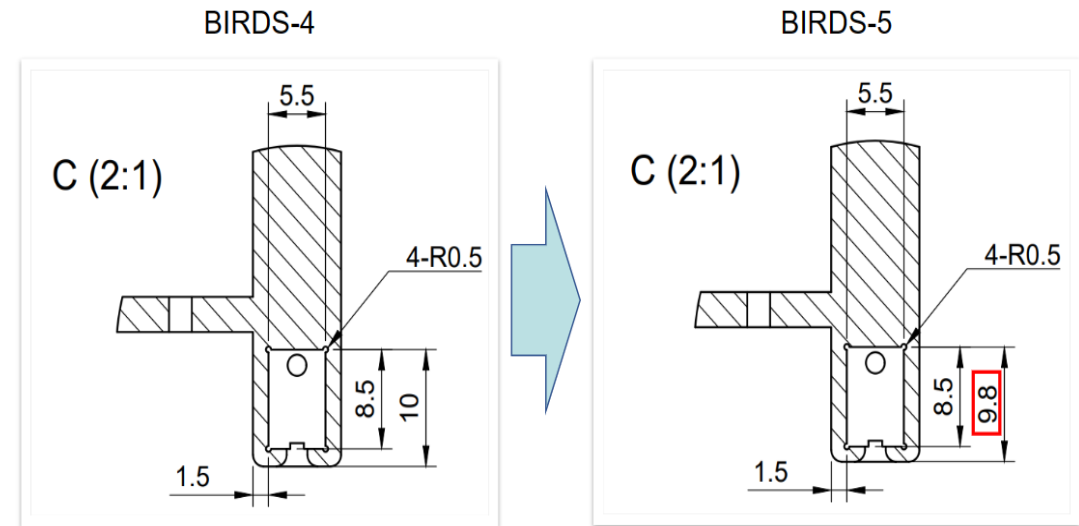
- Position changed from Birds4

BIRDS-4	BIRDS-5	Futaba
Depression length of the switch when the satellite is stored in the J-SSOD	1.5mm	1.3mm	1.2mm
Period of being stored from handover to release	5.5 months (2020/10/01 - 2021/3/14)	6 months(10%↑) 2022/6/7 - 2022/12/2	5.5 months 2022/02/24- 2022/08/12

□ **Unlikely**

=>Futaba design was in more severe condition

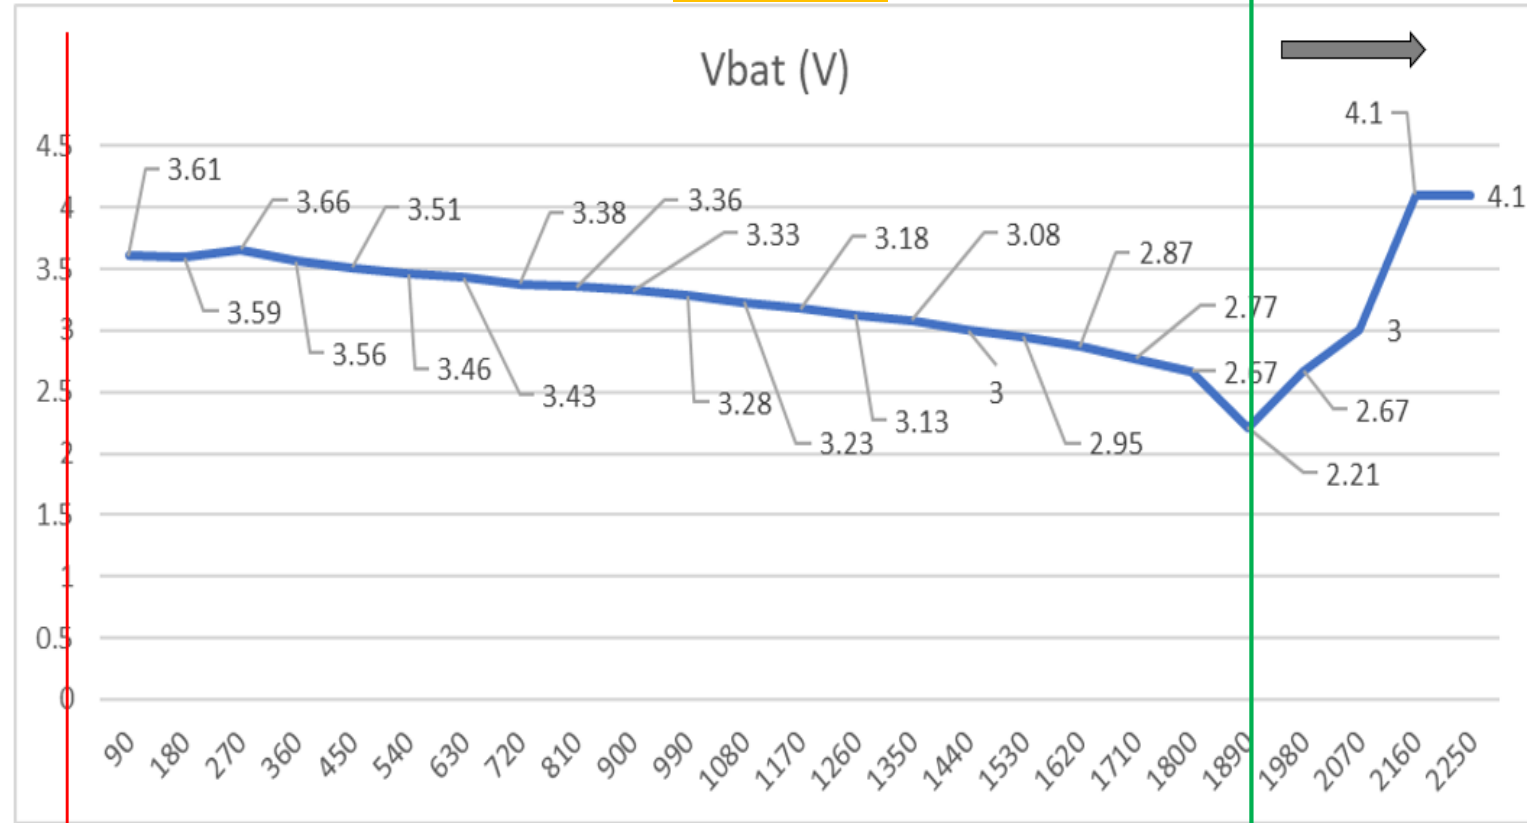
- TVT1 Results : **Chattering not successful**, No CW, No FM, Sat OFF
- TVT2 Results: **Chattering was successful**, No CW, No FM, Battery damaged, Sat ON

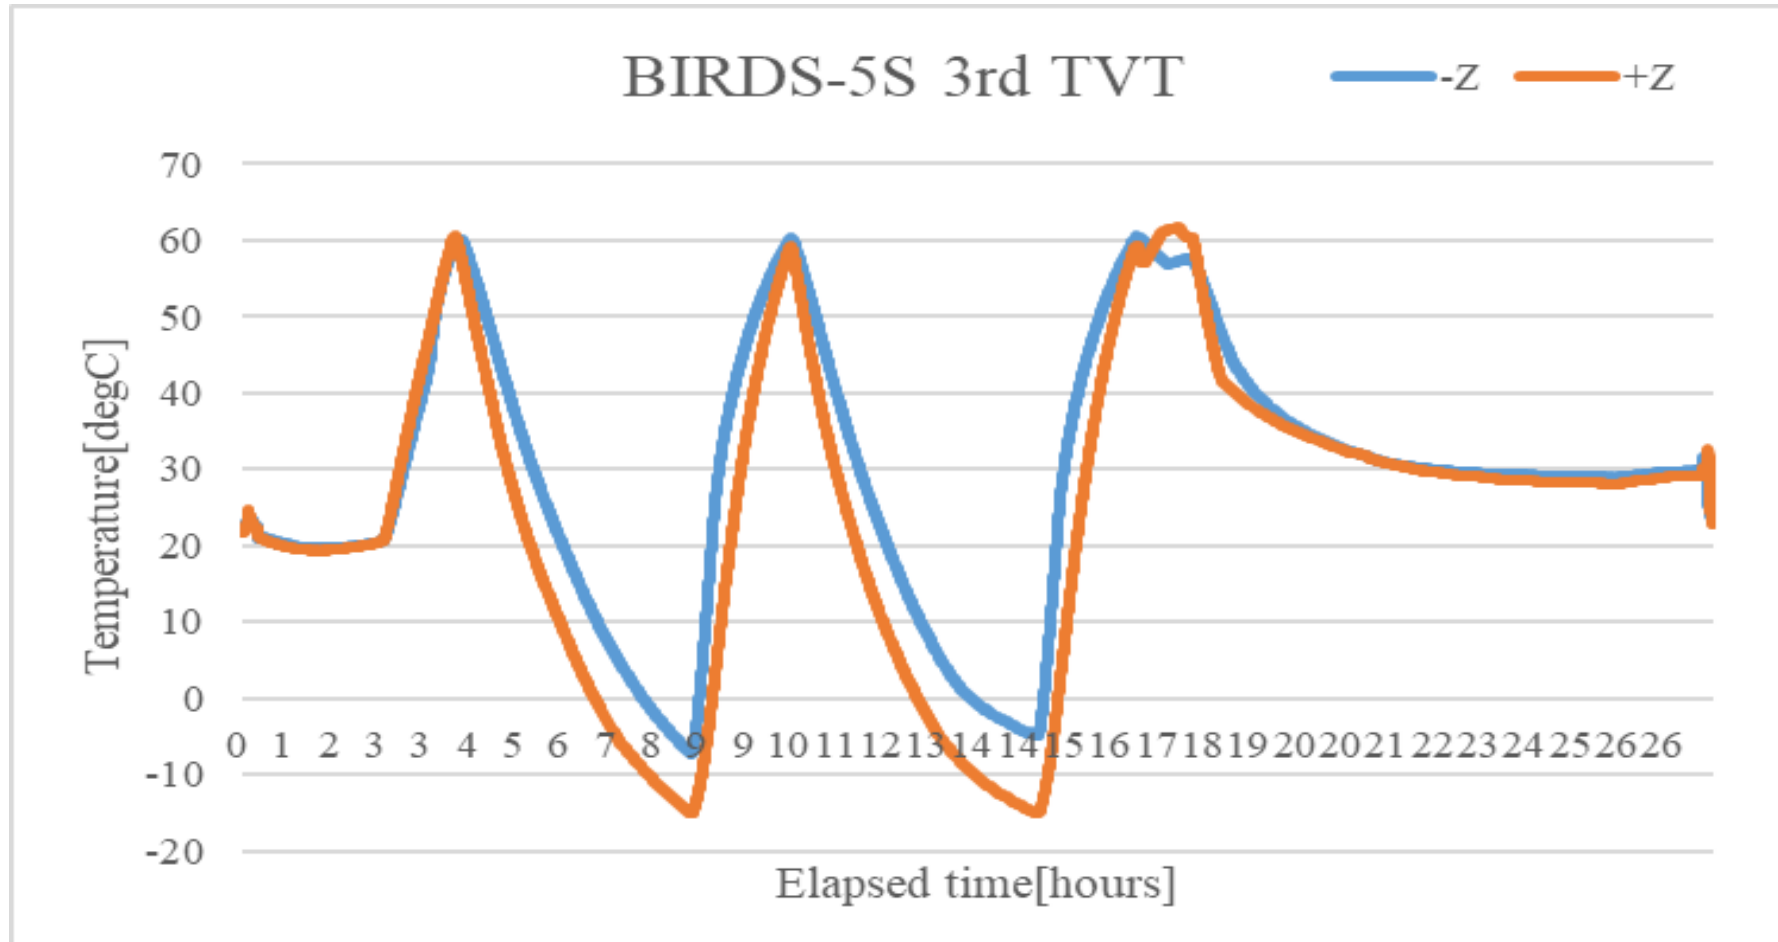
☐ CW received, FM command also confirmed, chattering was successful

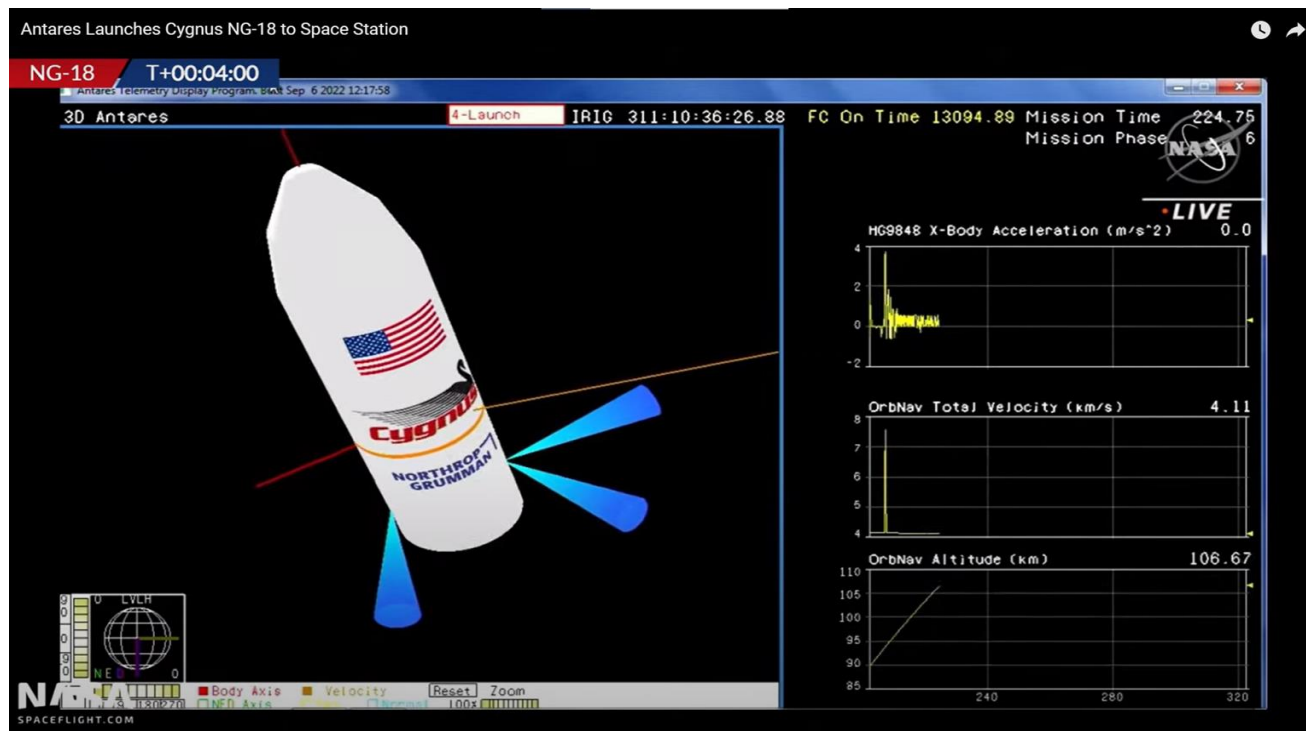
NG-18 (BIRDS-5)

- Direction was wrong after booster separation
- It has a spike at the time of separation
- Cygnus Cargo ship failed to deploy one of the solar array

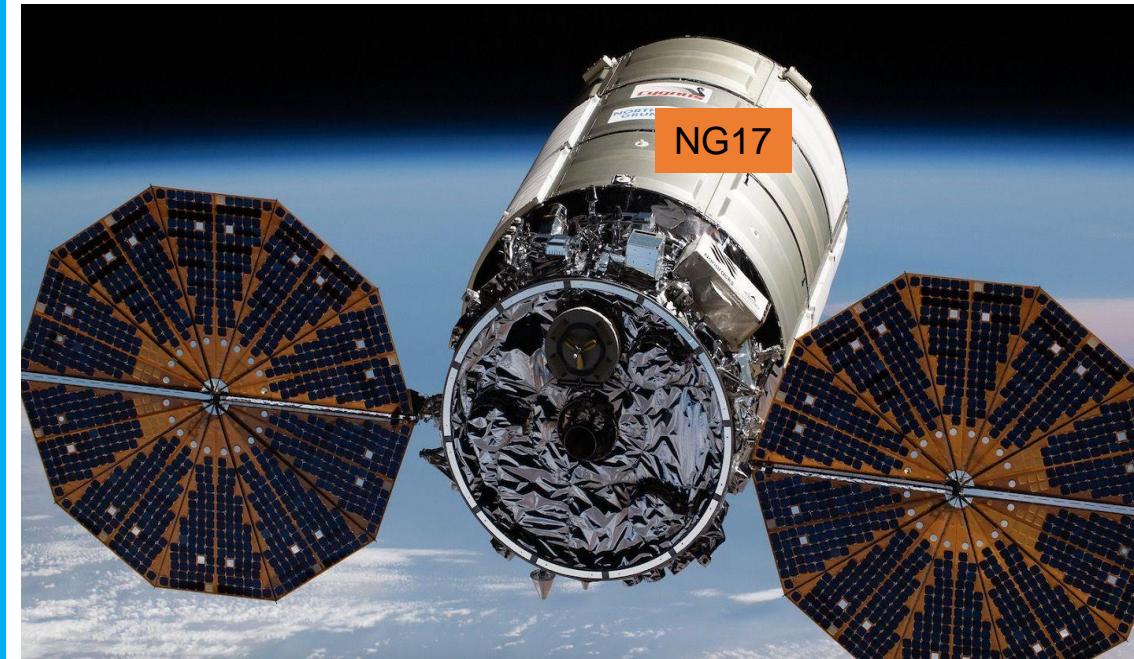
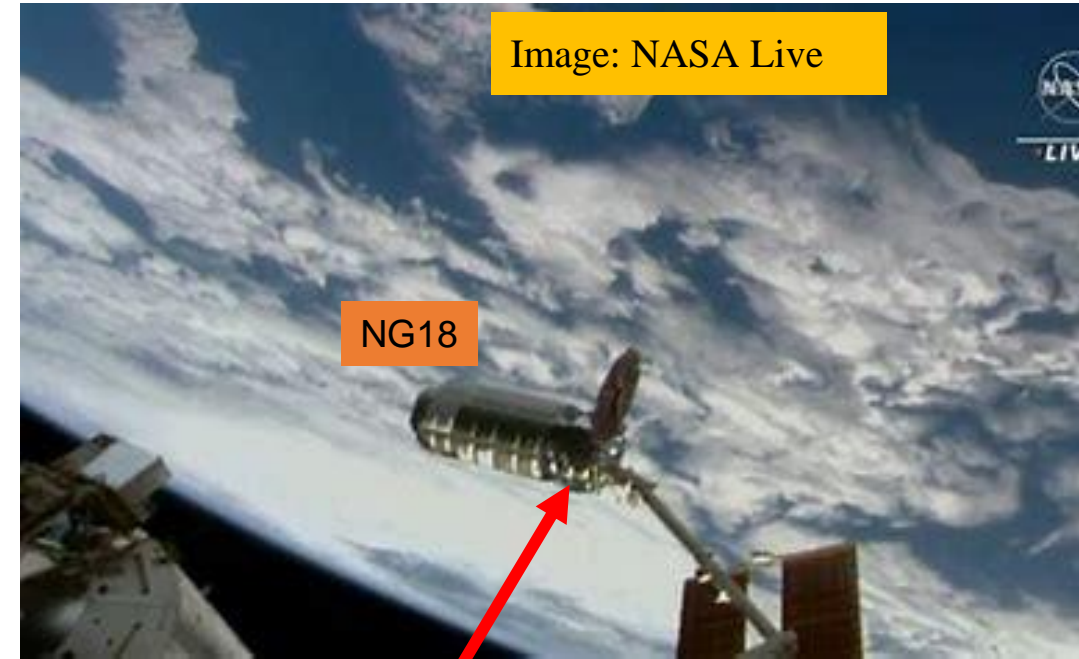
Only one solar panel deployed

In a statement late Nov. 9, Northrop Grumman blamed the failed deployment of the array on debris from the launch. “During a rocket stage separation event, debris from an Antares acoustic blanket became lodged in one of the Cygnus solar array mechanisms, preventing it from opening,” said Cyrus Dhalla, vice president and general manager of tactical space systems at Northrop Grumman. The company did not explain how the debris got into the mechanism, something the company has not reported happening on previous Cygnus launches.

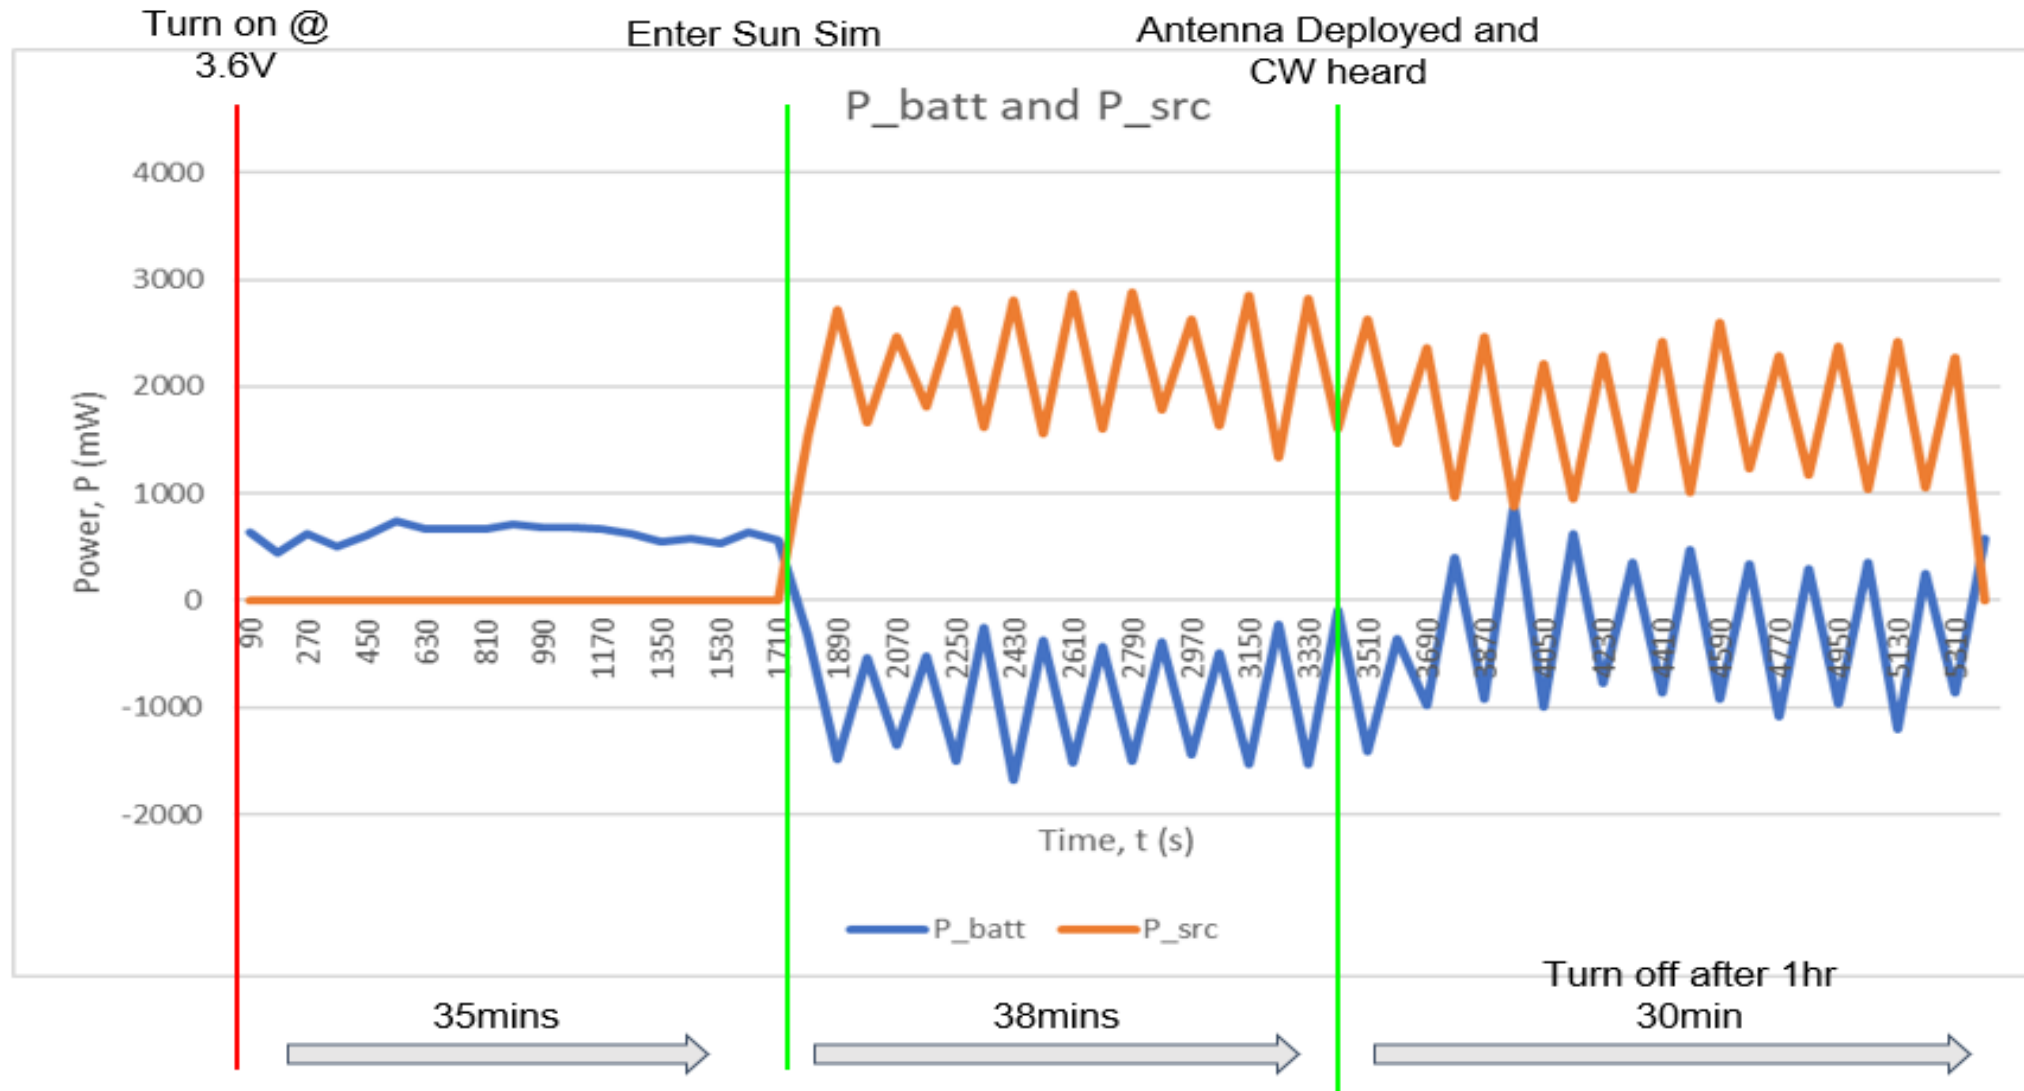
Battery Recovery test

- ❑ At 50% battery capacity, satellite was tested for
 - Activation and
 - Antenna deployment
- ❑ Condition
 - Vacuum: TVT
 - Atmosphere temperature: Clean room
- ❑ Results
 - No CW
 - Antenna did not deploy
 - Battery was damaged by TVT
- ❑ Solution
 - Charge satellite battery with sun simulator
 - After 38 mins, antenna deployed and CW heard

❑ Failure due to battery is therefore **denied**

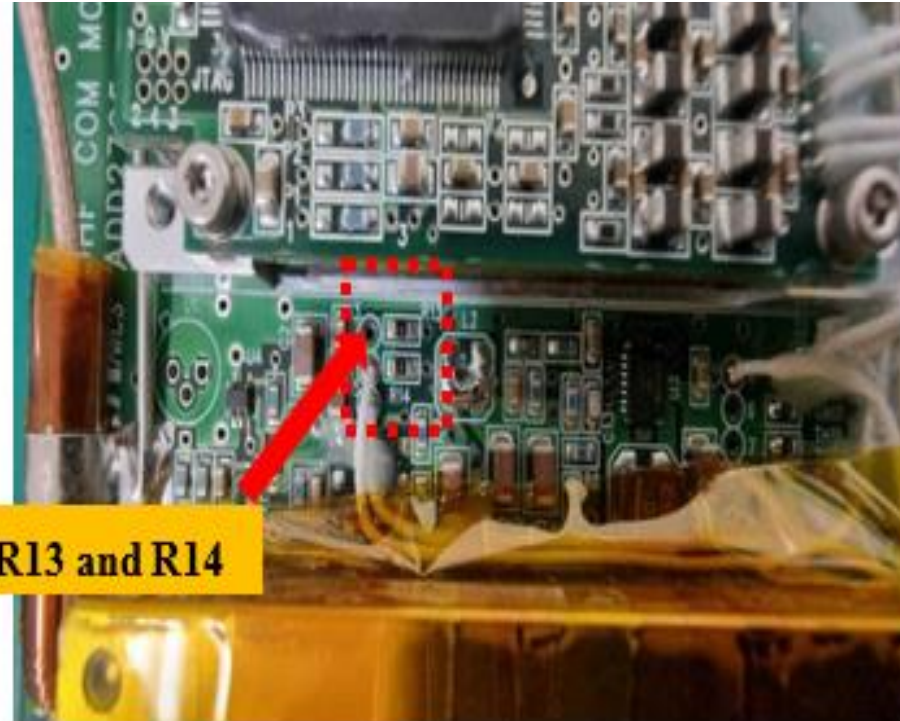
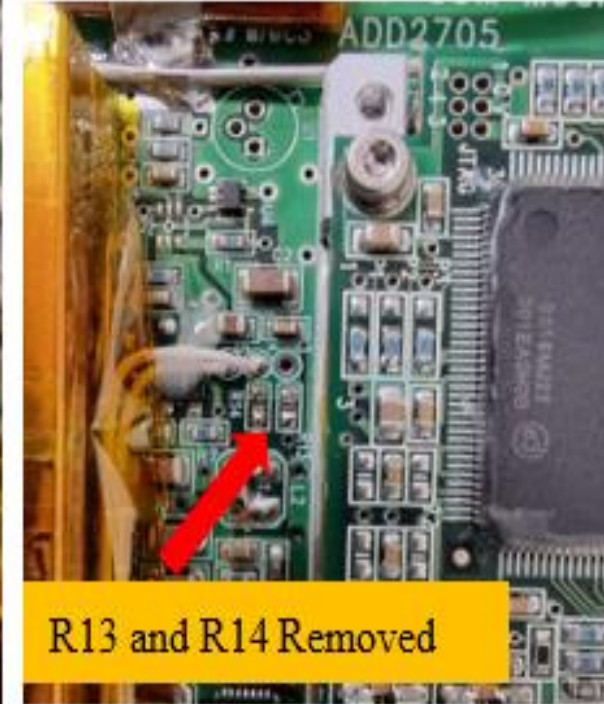
- Transceiver malfunctioning experienced at FM
- Reason: Transceiver design change
- Solution: R13 and R14 removed
- Unlikely**
 - Long duration test were good
 - Transceiver purchased on different batches
 - Cannot occur on all the three satellites

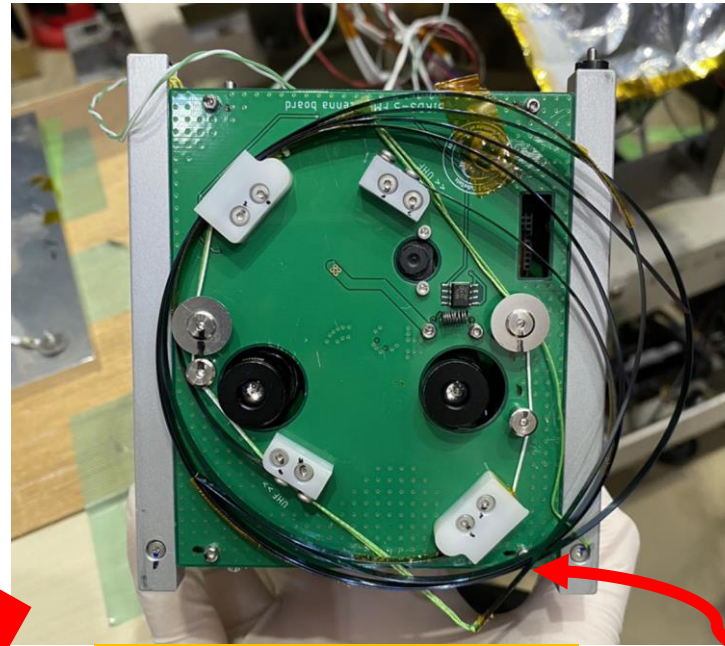
Partial deployment

- TVT 1: unsuccessful
 - Wrong FM code
 - Connectivity problem

- TVT2: unsuccessful
 - Battery Damaged

- TVT3: Partial deployment**
 - EM battery used

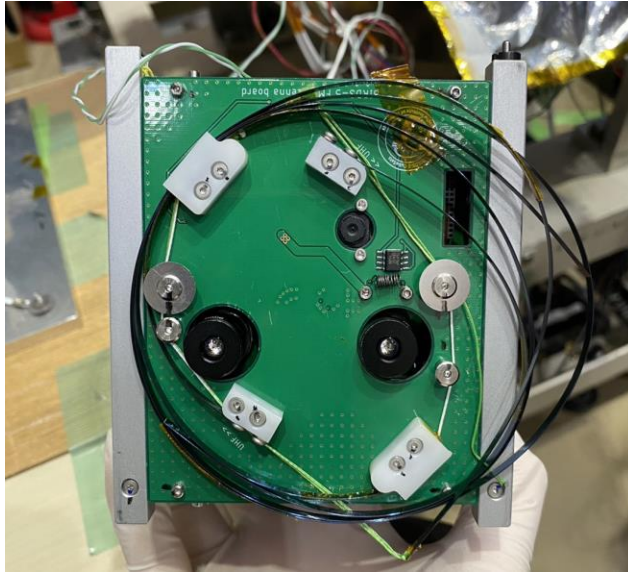
- ❑ TVT3 partial deployment (blocked by PETT Chamber)
 - A thermal ball was formed

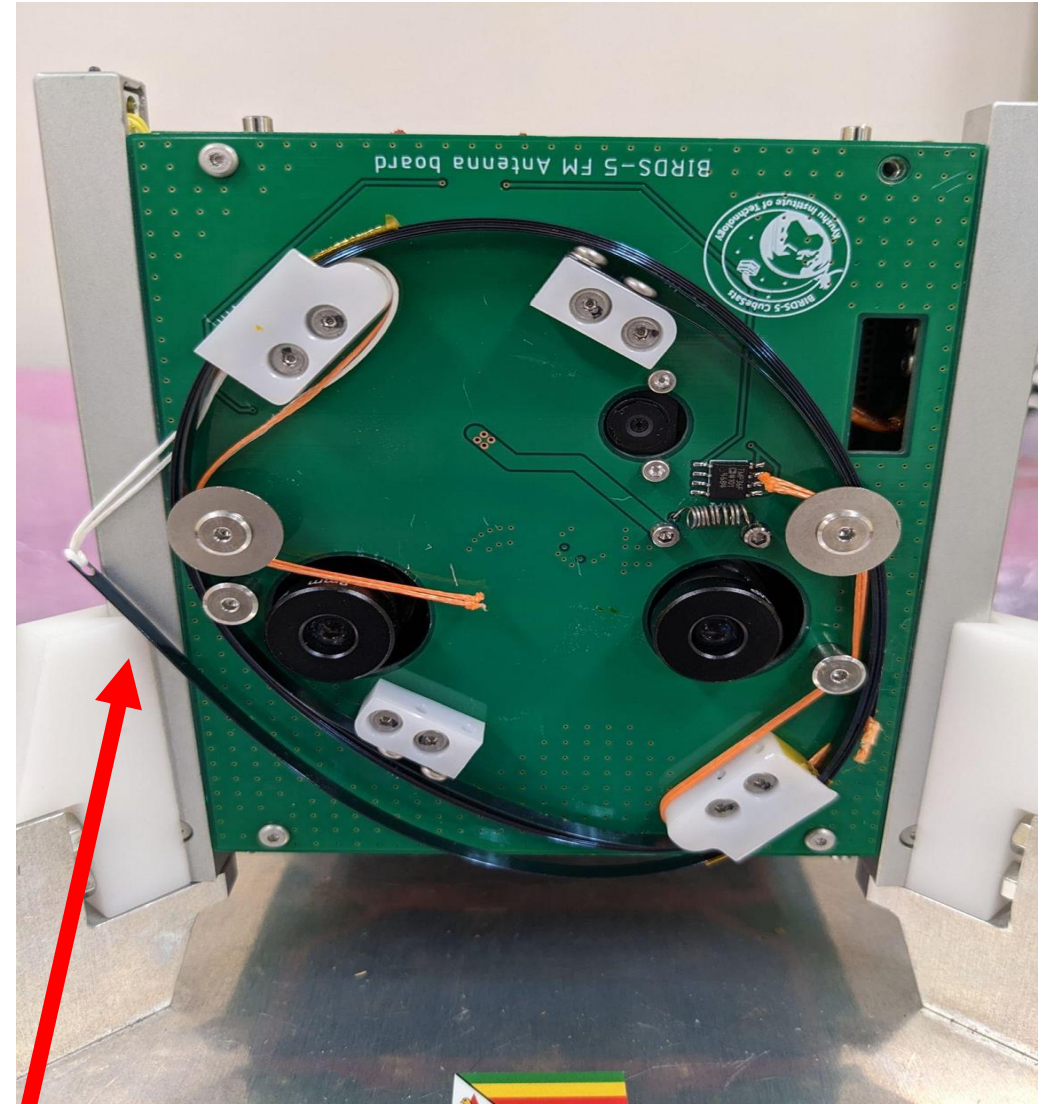
Blocked Here

- FM code, CW verified, normal operation
- Clear memory.
- SAT voltage measured at 3.61V
- SAT chattering testing then turn on
- No deployment, no CW after 35 mins
- Place into sun simulator at 36 mins
- Antenna deployed and CW at 1hr 07min,
however thread cut but antenna remained furled
- Deployment was blocked by satellite stand

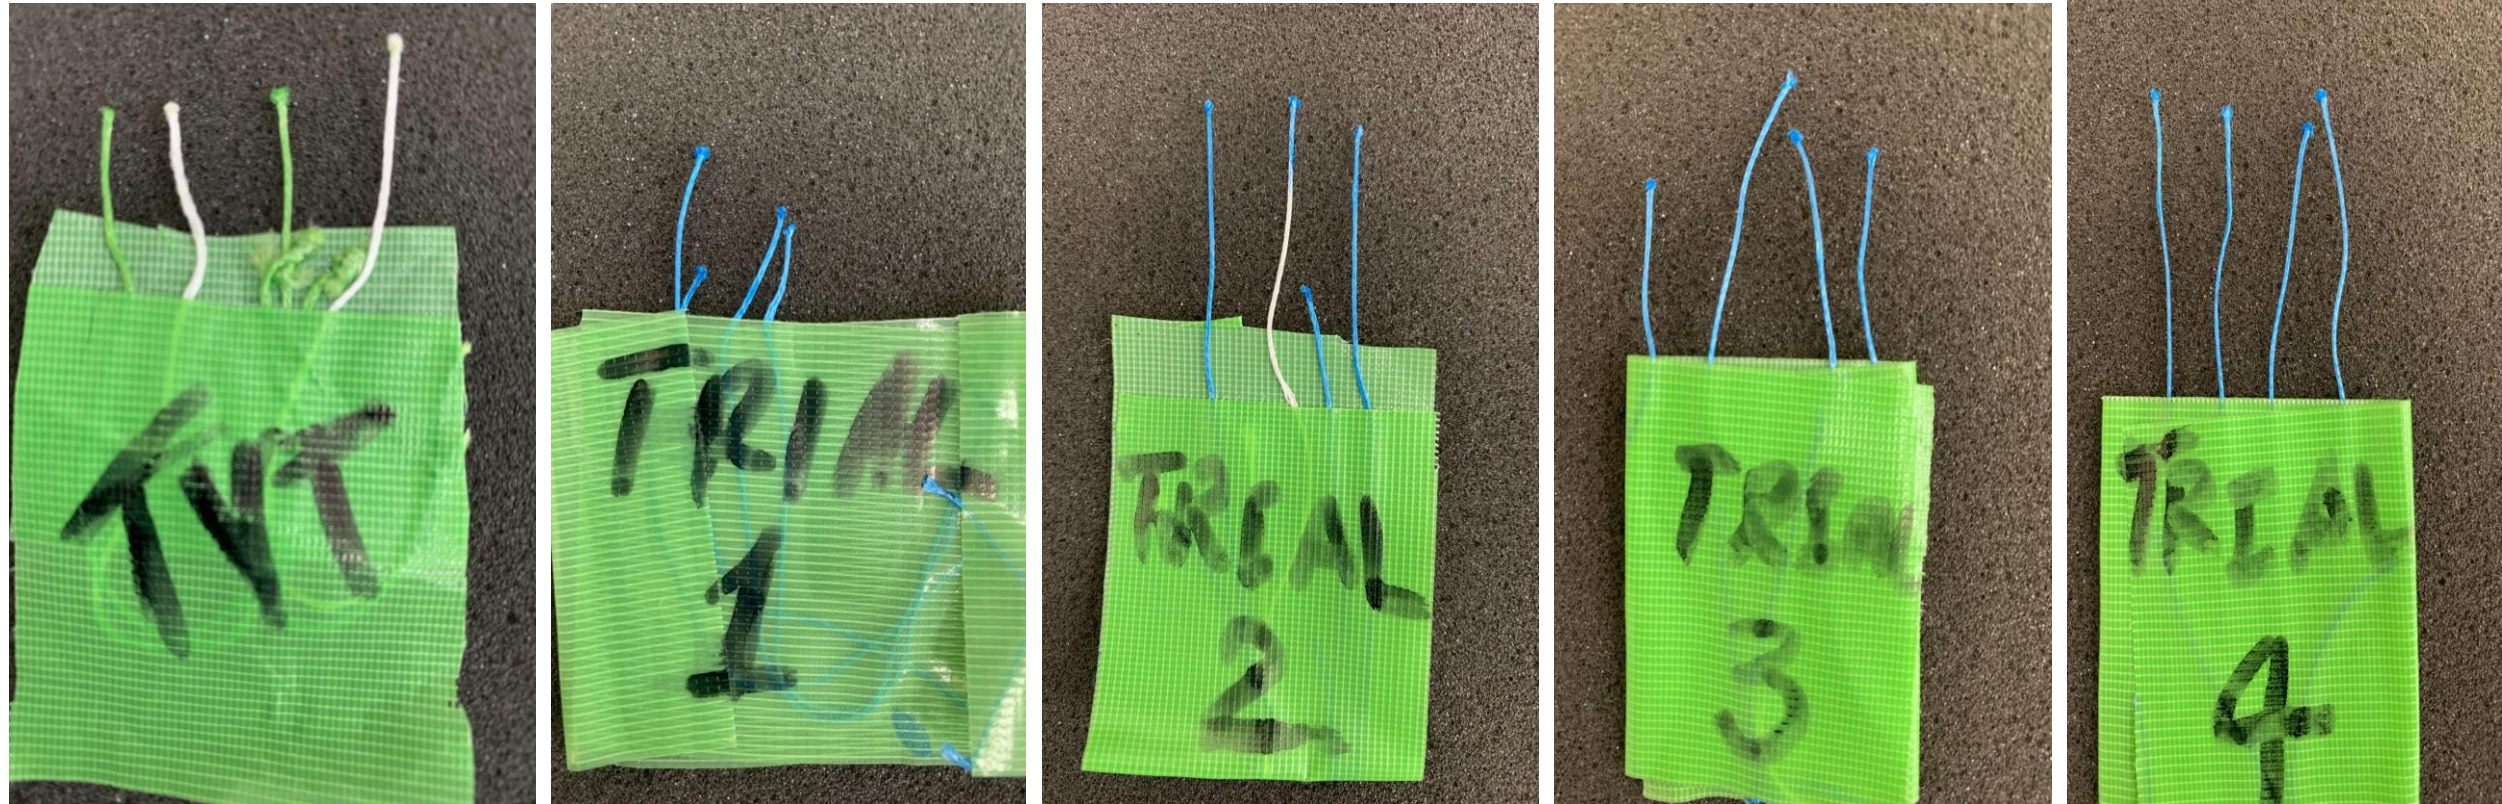
- The fishing wire ball from TVT is slightly bigger by a very small margin hence **denied**

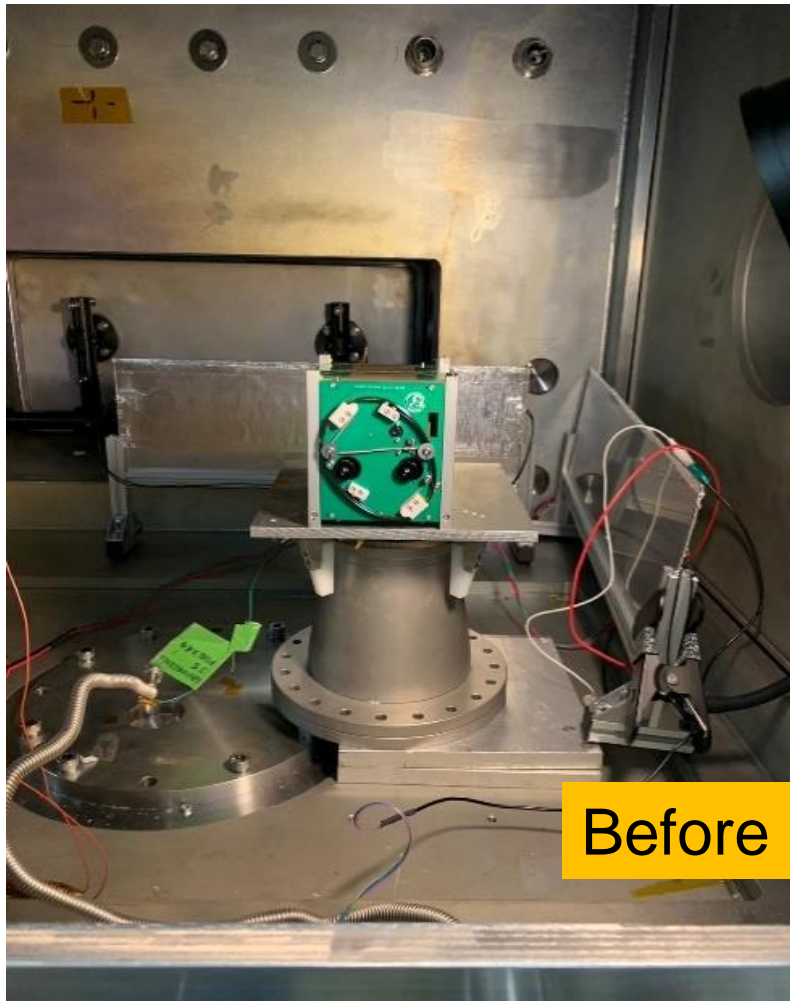
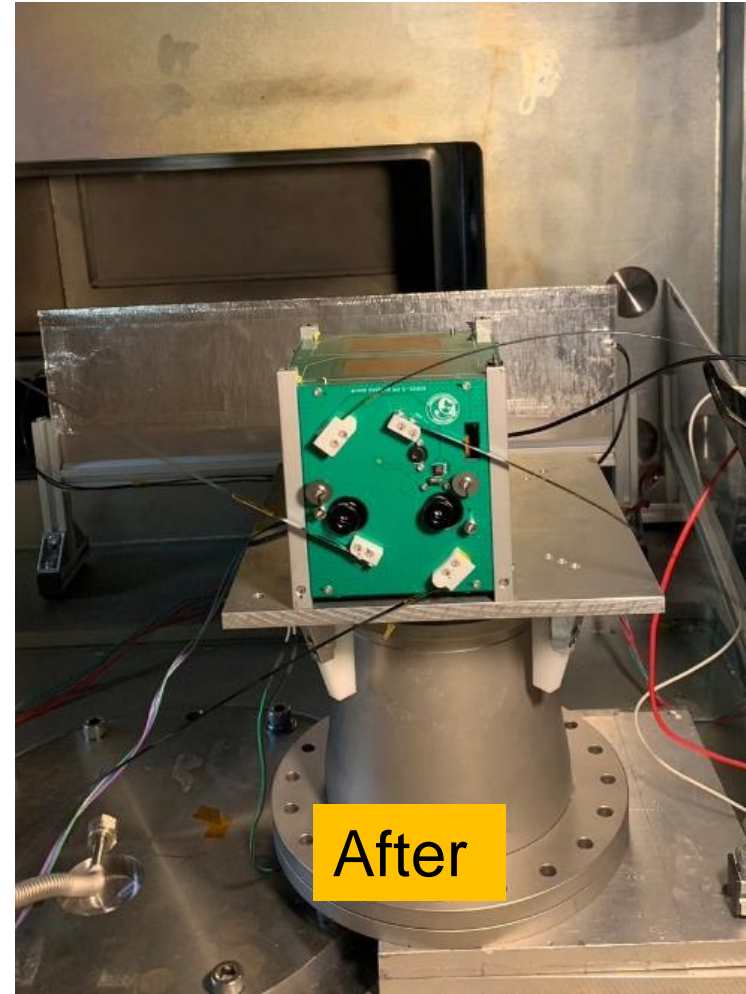
Successful

D. TVT4 (Square chamber): Full deployment

- Vacuum Only
- Failure was therefore **denied**

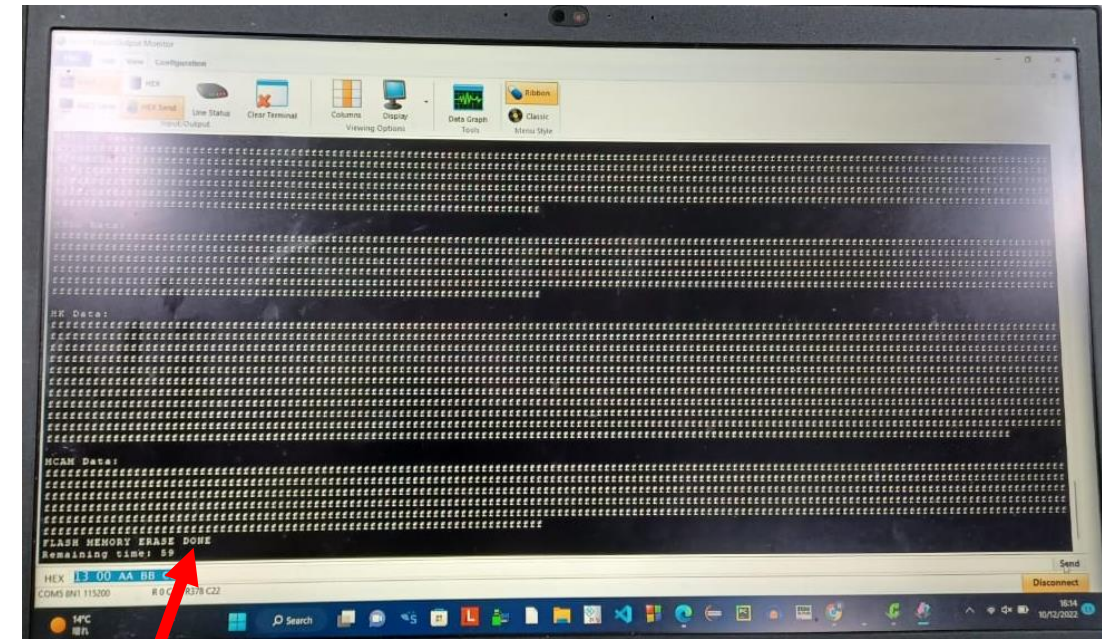
Flash Memory Erase Confirmed

- Deployed occurred as planned
- Deployment could not occur at voltages below 3V
- Even if no deployment, deployment counter increment
- Satellite did not wait for 24hrs to retry deployment and increment counter
- Unlikely**: Satellites were reset and memories flashed

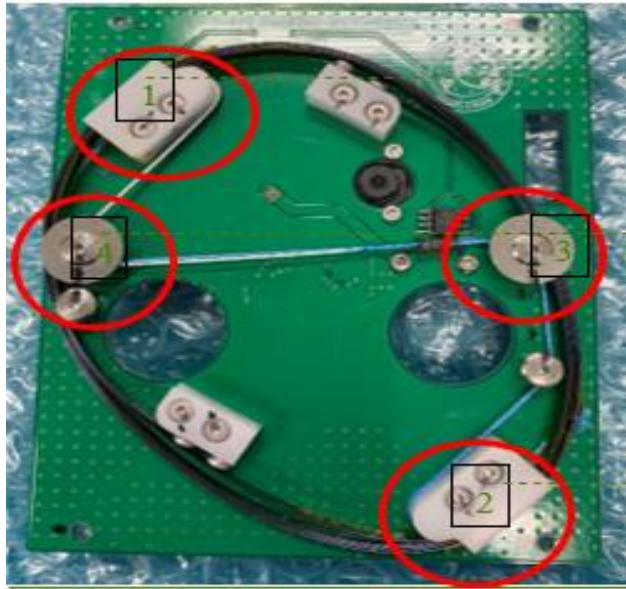
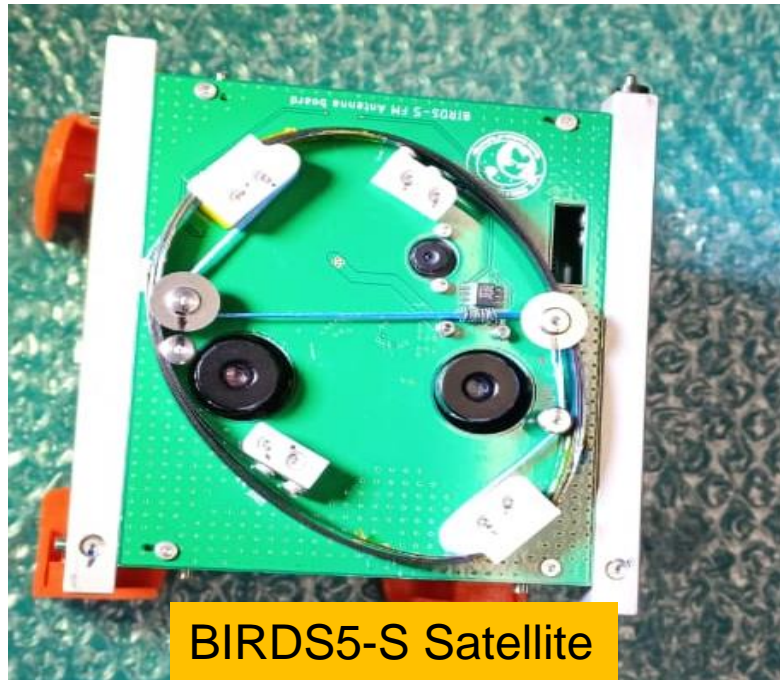
BIRDS5-S Satellite

- ❑ On points 1 and 2 it can get stuck under the antenna where the fishing wire crosses the antenna elements
- ❑ On points 3 and 4 the fishing wire can get pressed under the antenna guides when the antenna is stowed too tightly.
- ❑ This was known and was avoided at EM and FM
- ❑ **Denied:** Antenna deployed with proper tying method

Note: This was noticed when deployment was blocked by PETT chamber and satellite stand.

- To increase the height of the antenna guides so that the fishing string will have more margin of passing under the antenna elements
- Do antenna deployment under vacuum conditions using thermal vacuum chamber
