Birds webinar

Lesson learned from manufacturing of 1st to 3rd CIT Birds satellite

Tetsuro Harada
Chiba Institute of Technology
2023/11/08

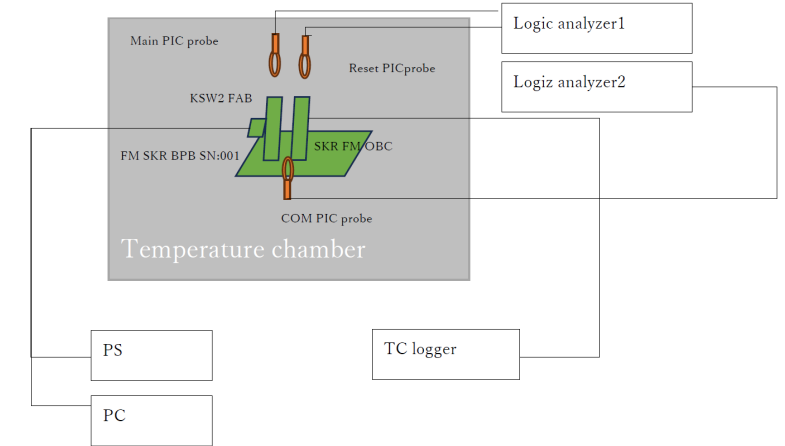
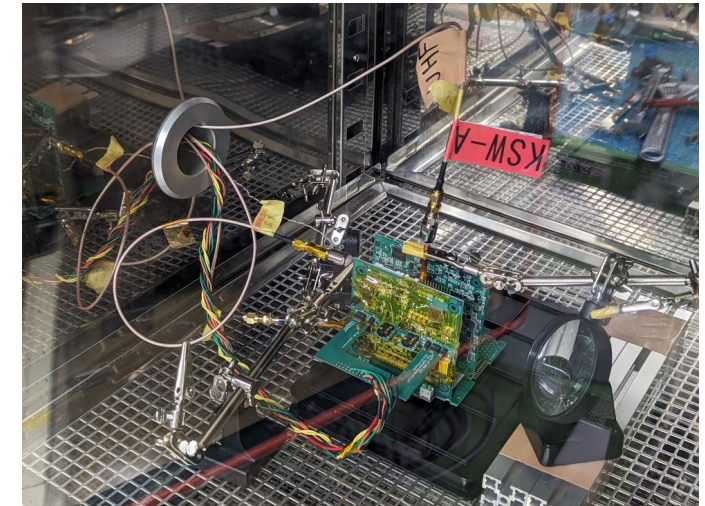
- Right figure is configuration
 - Right bottom is configuration photo
- OSC frequency is measured by loop ant if OSC is work or not

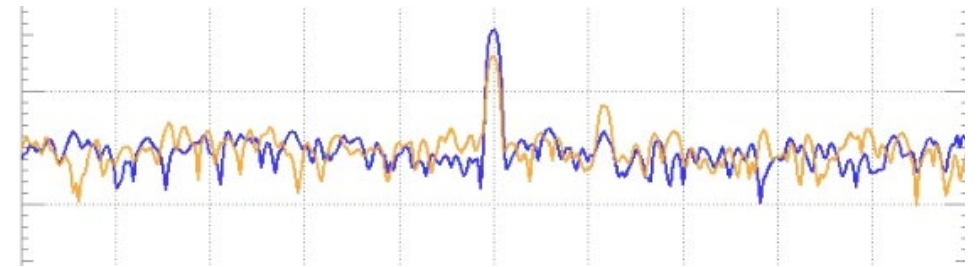
fig1 nominal

- Data Confirms Main PIC OSC does not work indicated by orange at high temp (Blue is compic)
- One of root cause of frequency margin.
- In any case, frequency margin is not taken into consideration. The margin need to be measured.
- For detail report, refer to SKR_PKG_104. only Japanese, no English.

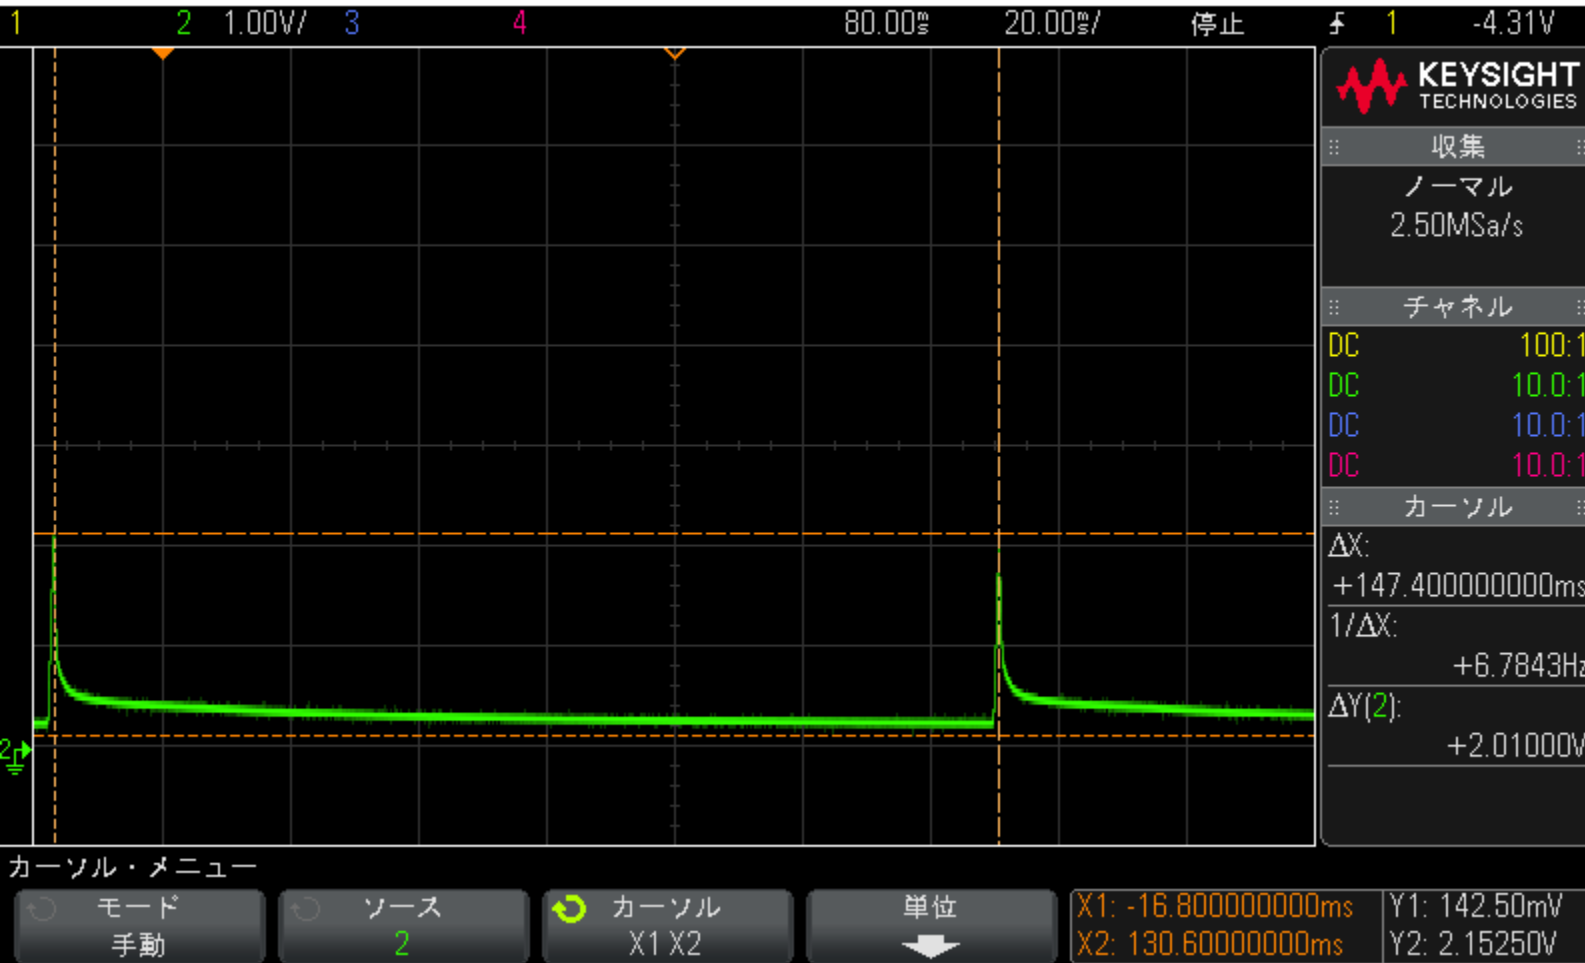
3V3_MP @50°C

After 2.1V then drop voltage.

After 147ms, then same issue happed.

According to datasheet, OCP will cut mosfet after 130ms.
It is consistent to this issue.

OCP worked.

For further investigation, remove RS-232 Chip then test again.

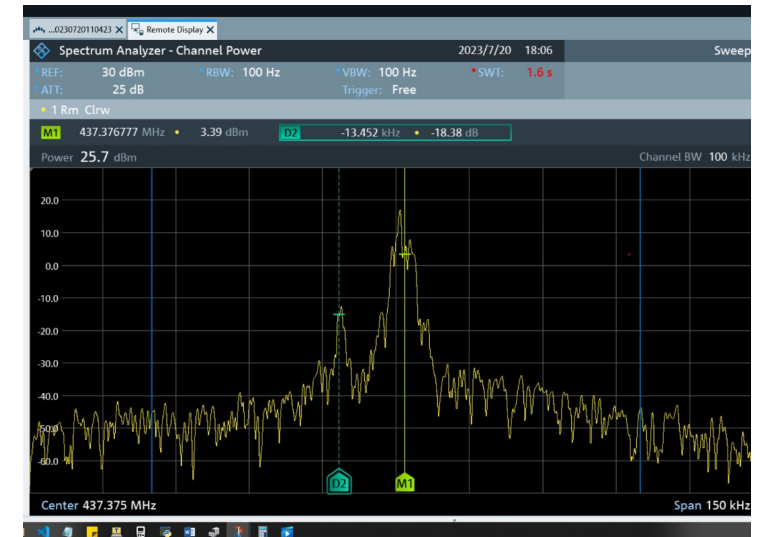
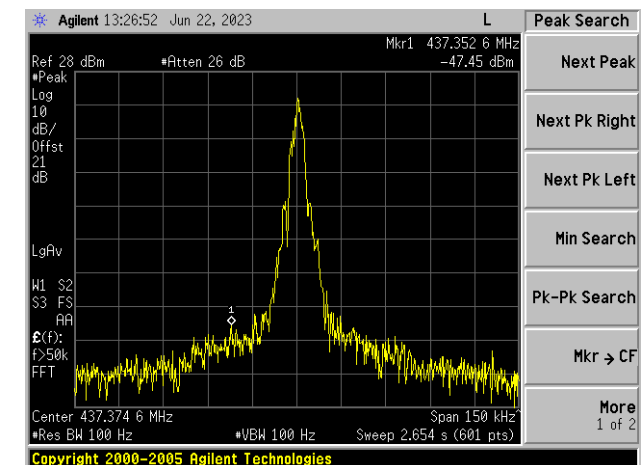
- Inspection by So-tu-kyoku found spurious in spectrum analyzer(FPC1000) in the upper photo.
 - Agilent spectrum analyzer was okay.
- Rohde & schwarz confirmed that this issue occurred due to software bug.
 - To be updated for future software update.
- Spectrum analyzer over 3MYen will be fine or Use Inspection company 200k yen per satellite.
