Lessons Learnt and Findings from BIRDS5-FTA

08/03/2023

BIRDS 5 Status

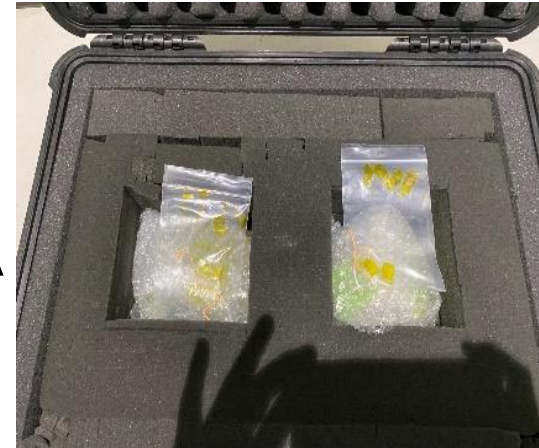
- ❑ **Denied:** RBF pins removed by JAXA

RBF pins returned to Kyutech

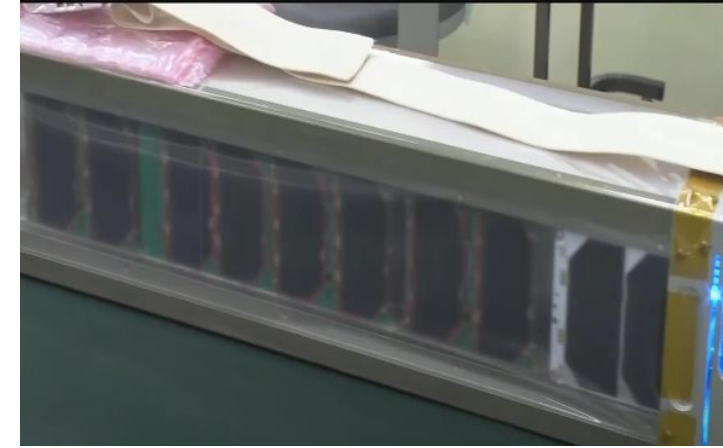
No RBF pins seen in JAXA's video

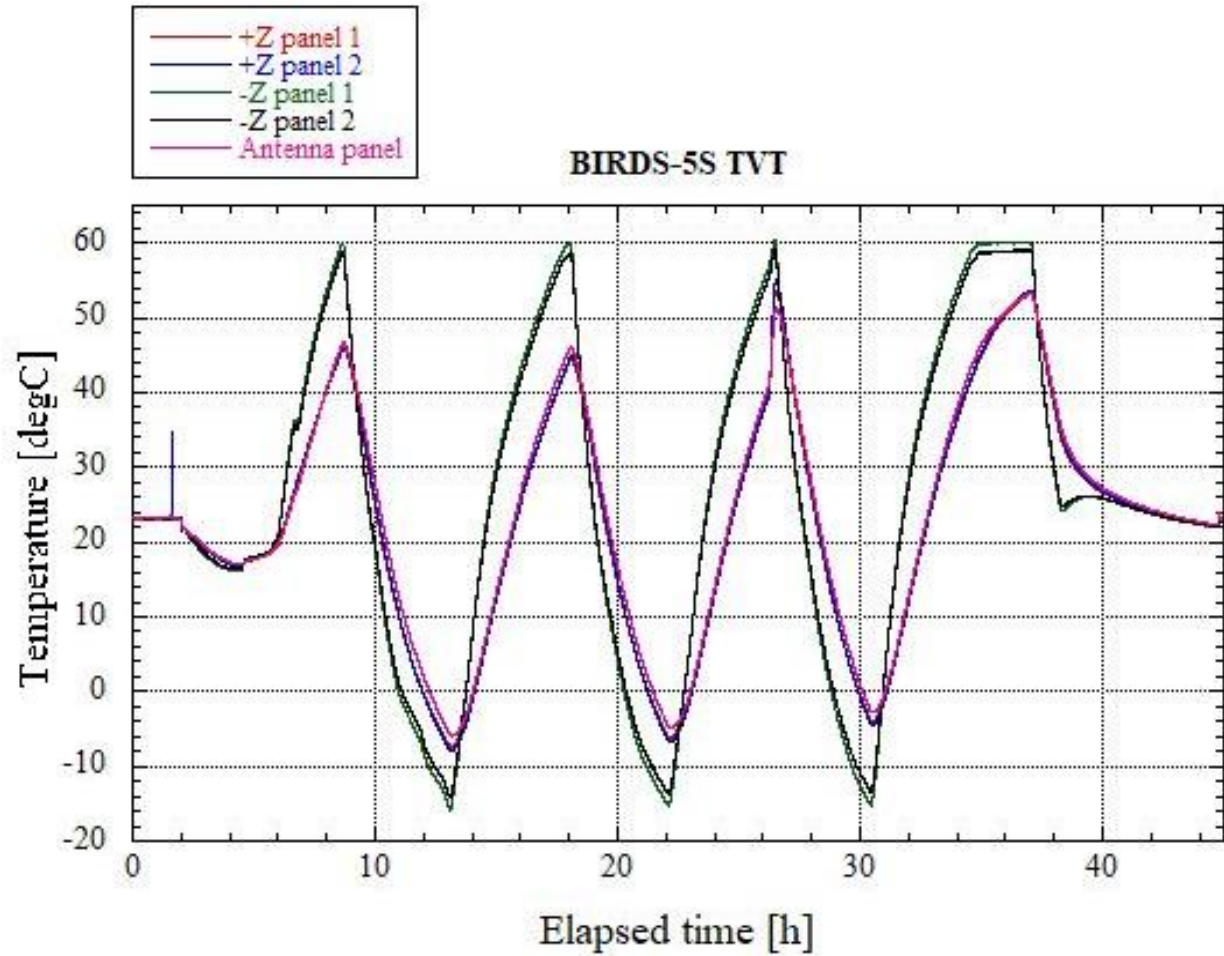
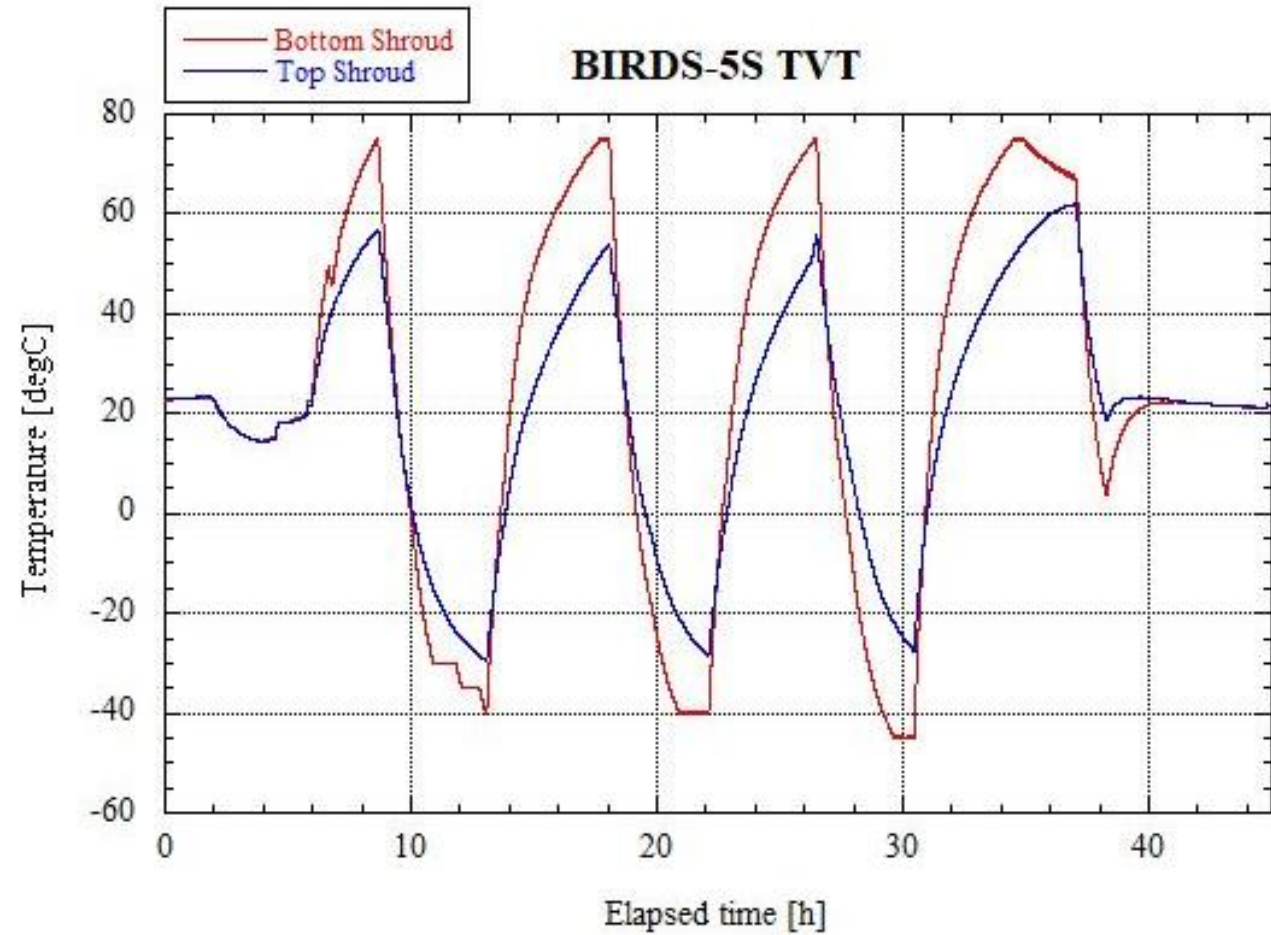
Longest ON time: 27 mins

- TVT1 Results : **Chattering not successful**, No CW, No FM, Sat OFF
- TVT2 Results: **Chattering was successful**, No CW, No FM, Battery damaged, Sat ON

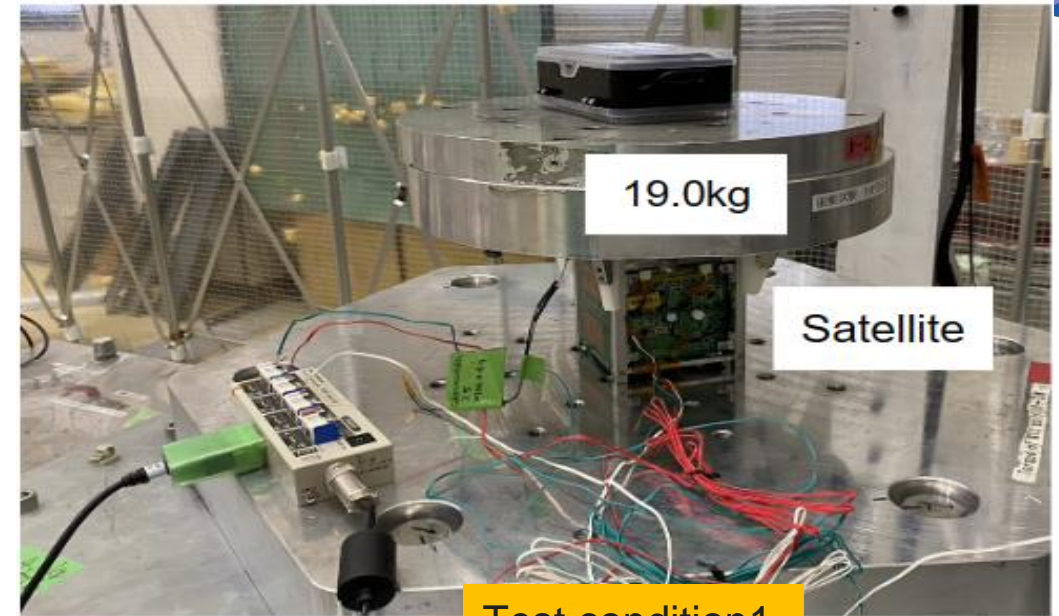
Test condition1

- ✓ Random and sine burst vibration
- ✓ Total force to the four rails: 19Kg(186.6N)
- ✓ Functionality was okay hence **unlikely**

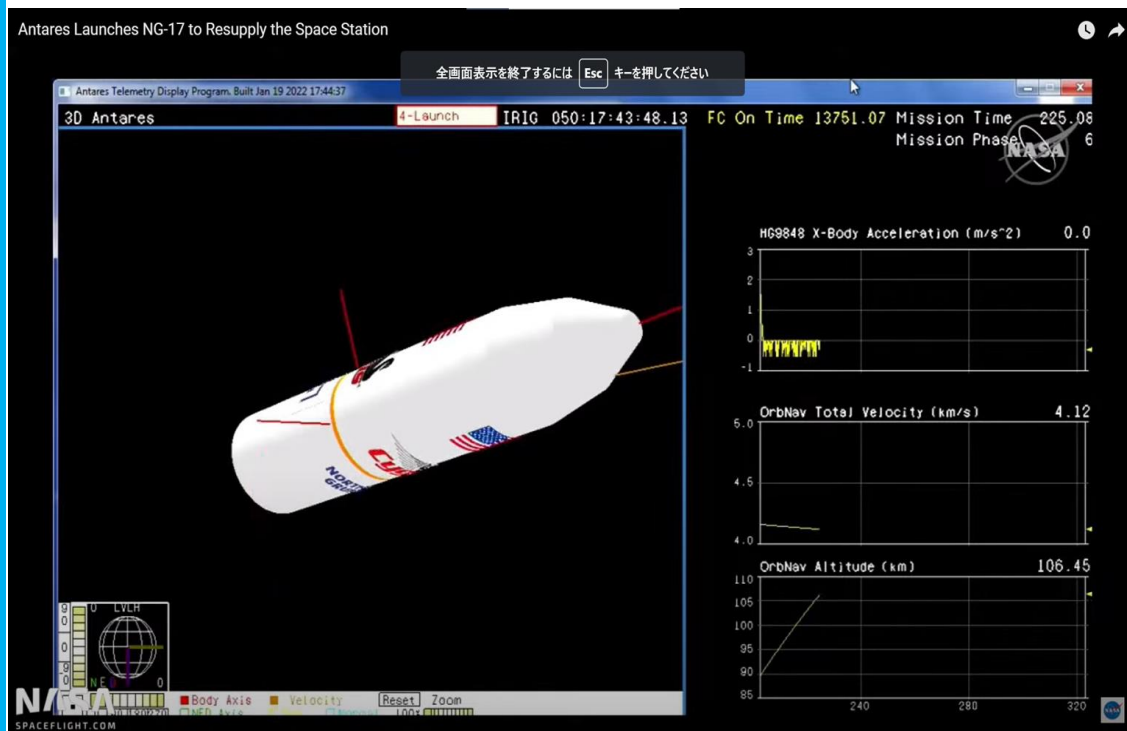
NG-17 (KITSUNE)
→Looks good

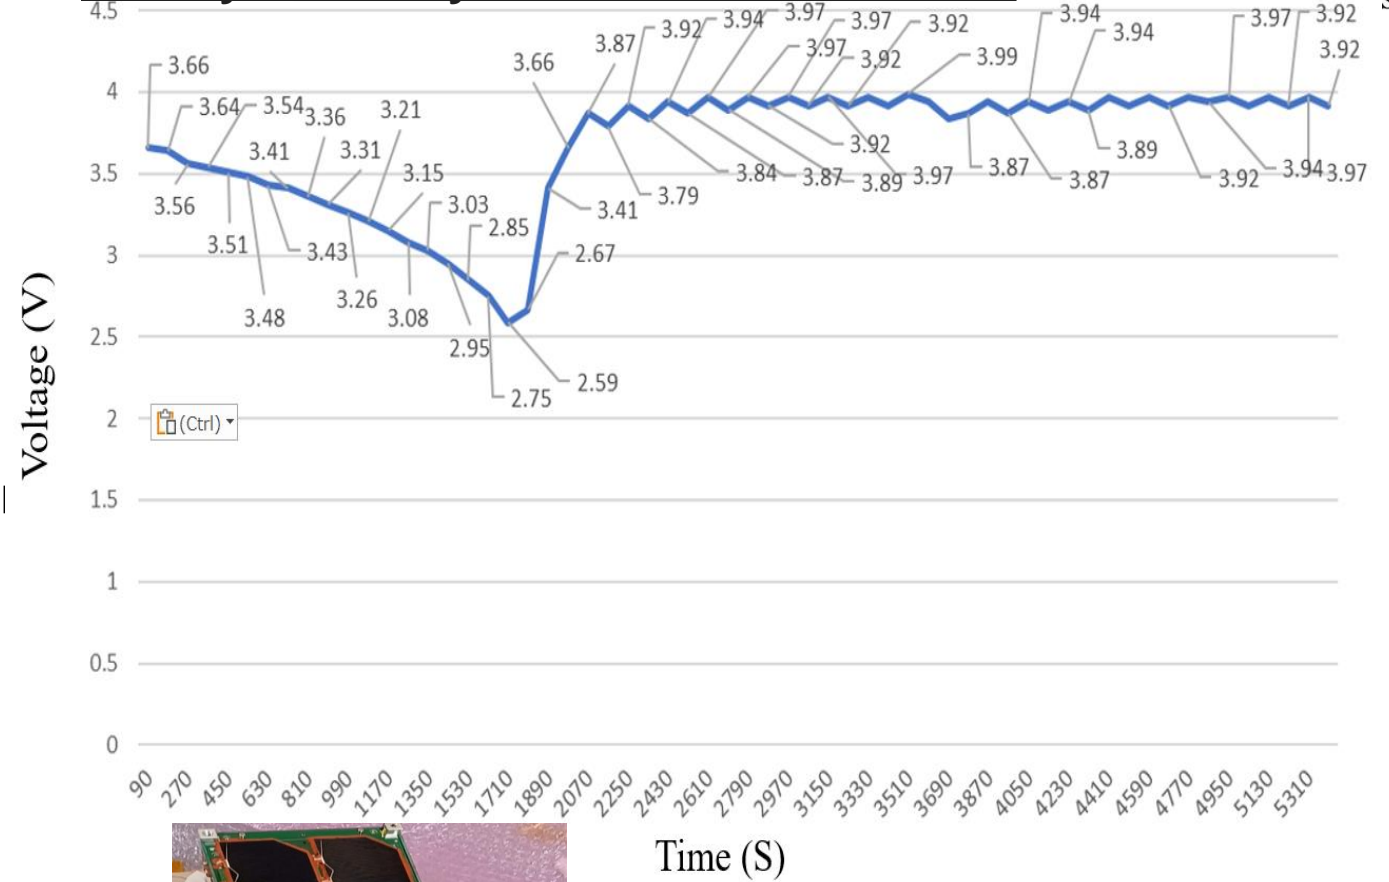
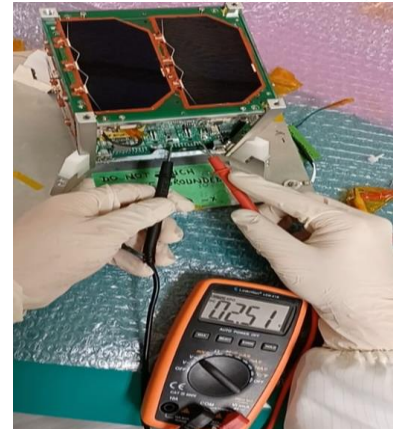
2.51V Battery Voltage

- ❑ At 50% battery capacity, satellite was tested for
 - Activation and
 - Antenna deployment
- ❑ Condition
 - Vacuum: TVT
 - Atmosphere temperature: Clean room
- ❑ Results
 - No CW
 - Antenna did not deploy
 - Battery was damaged by TVT
- ❑ Solution
 - Charge satellite battery with sun simulator
 - After 38 mins, antenna deployed and CW heard

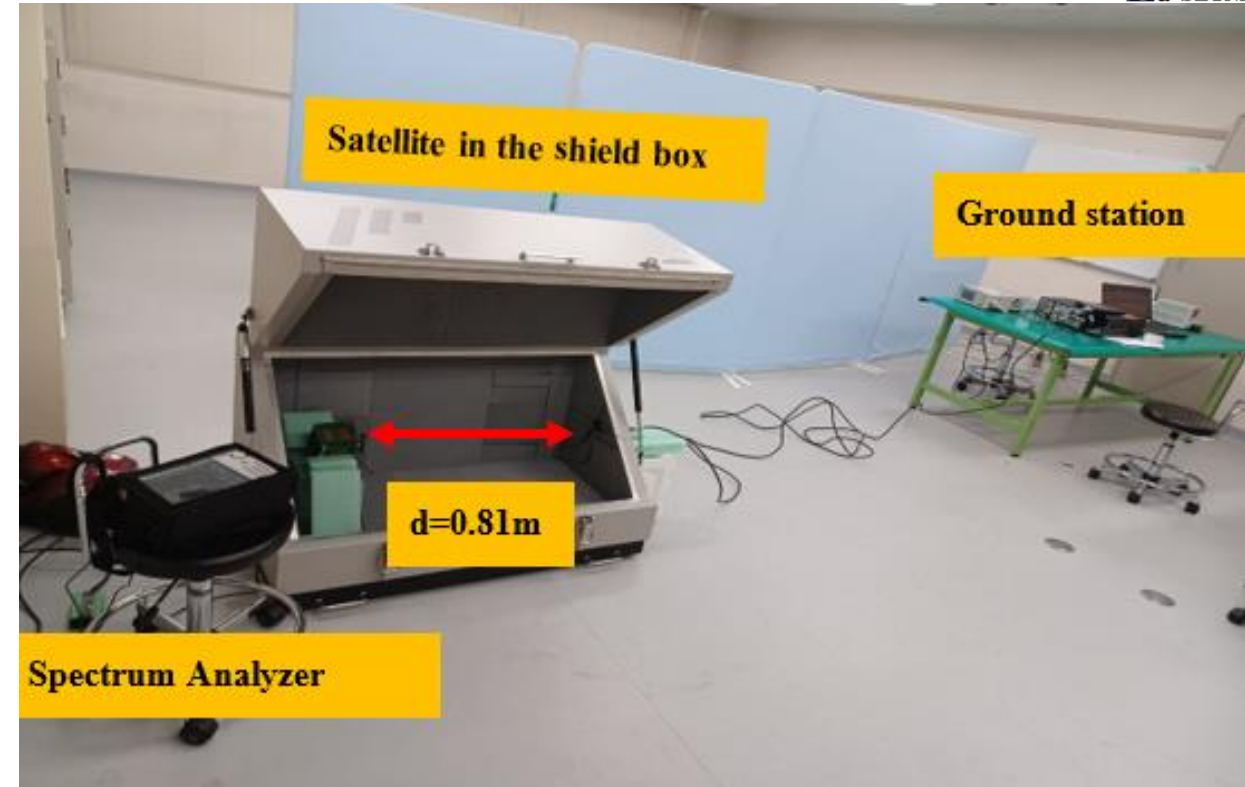
- No enough link margin?
 - Denied**
- Sensitivity was reverified using RF shield box
 - Sensitivity was -99dBm (BIRDS5-S)
 - Similar to anechoic and short range test results
- Link Budget (Uplink) was calculated
 - **There is enough link margin**

Satellite	Link Margin					
	10° Elevation	20° Elevation	50° Elevation	70° Elevation	80° Elevation	90° Elevation
BIRDS-5FM	5.3 dB	8.6 dB	14.3 dB	15.9 dB	16.3 dB	16.43 dB
BIRDS-5S FM	4.3 dB	7.6 dB	13.3 dB	14.9 dB	15.3 dB	15.4 dB

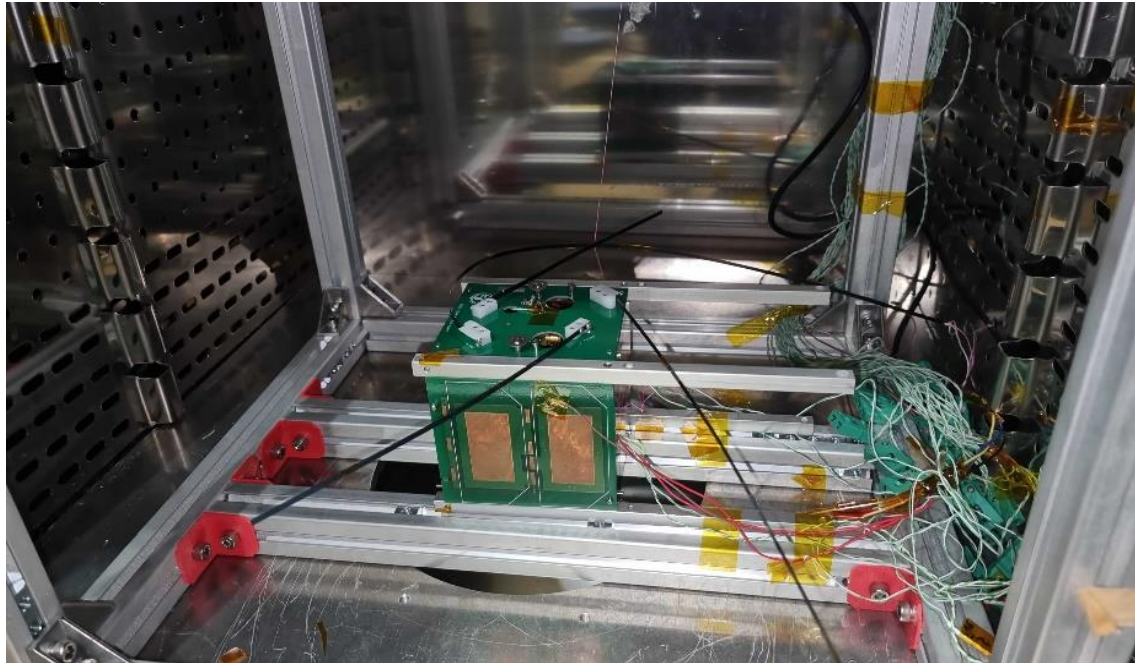
- ❑ Successful @ -30 degrees

- ❑ In orbit Antenna deployment was set to occur @ 17:20 JST satellites were not in eclipse
- ❑ Low temperature deployment failure **denied**

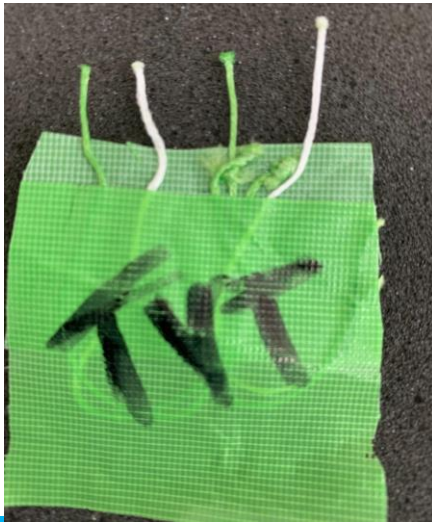
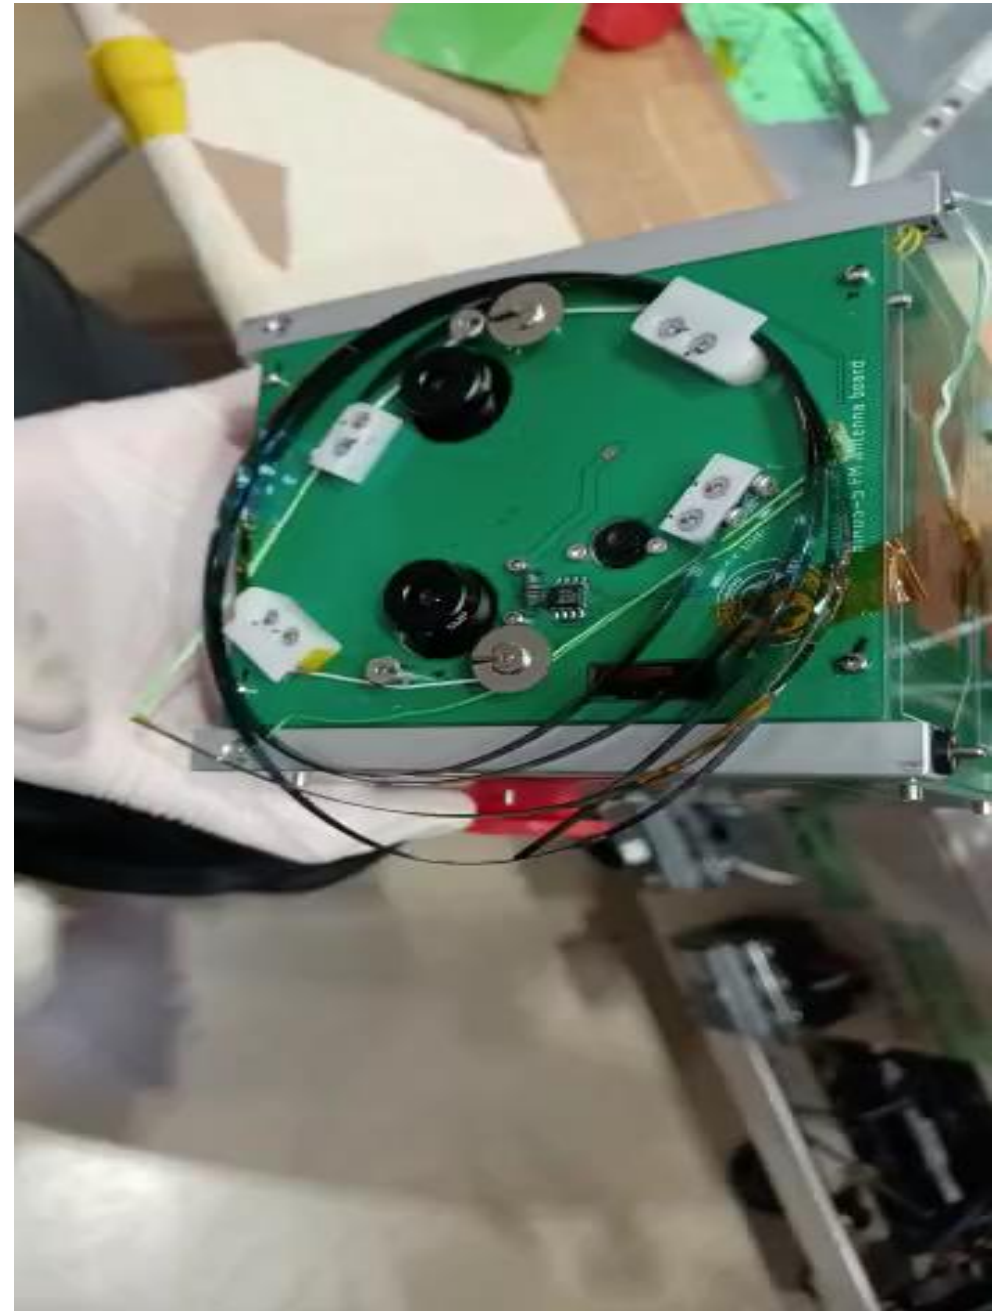
- ❑ TVT3 partial deployment (blocked by PETT Chamber)
 - A thermal ball was formed

- FM code, CW verified, normal operation
- Clear memory.
- SAT voltage measured at 3.61V
- SAT chattering testing then turn on
- No deployment, no CW after 35 mins
- Place into sun simulator at 36 mins
- Antenna deployed and CW at 1hr 07min,
however thread cut but antenna remained furled
- Deployment was blocked by satellite stand

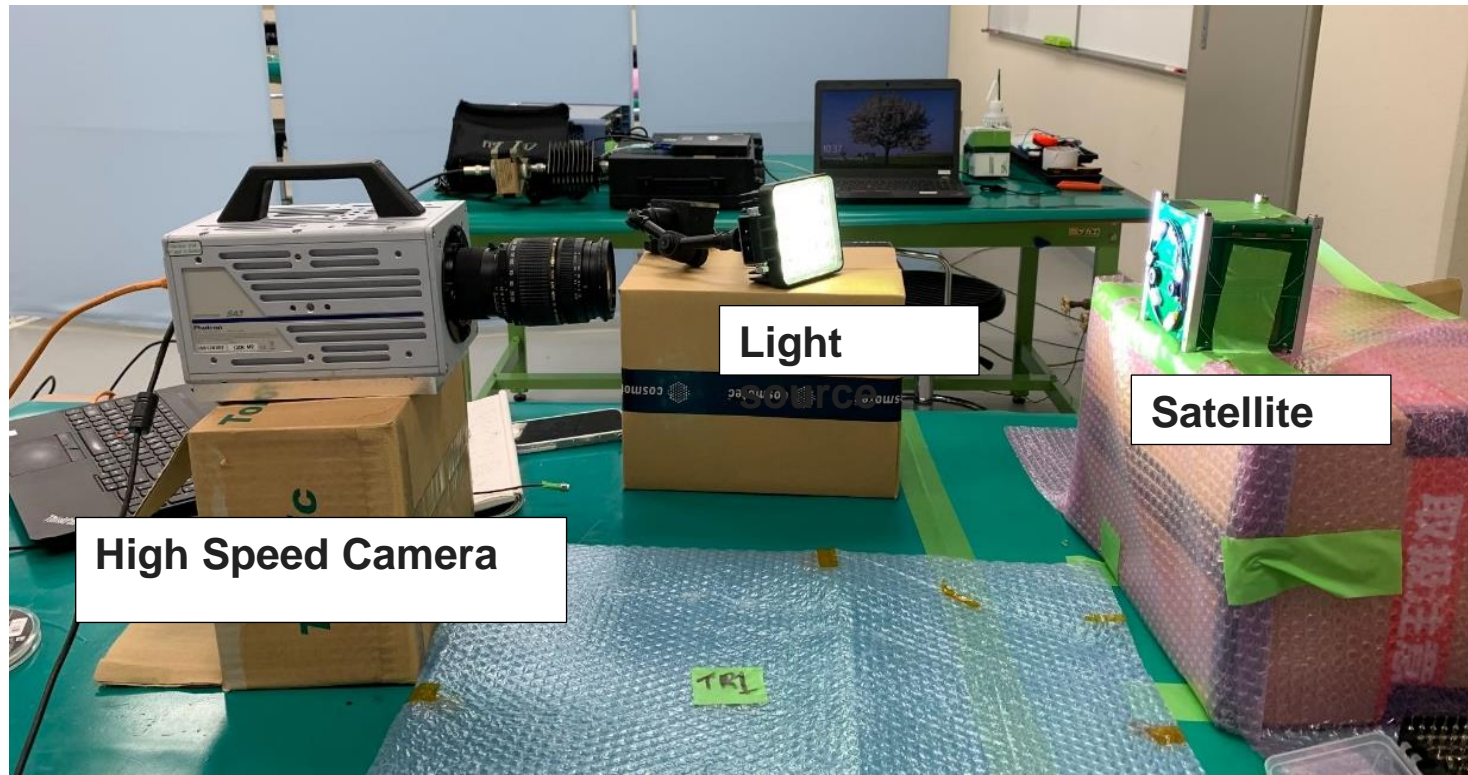
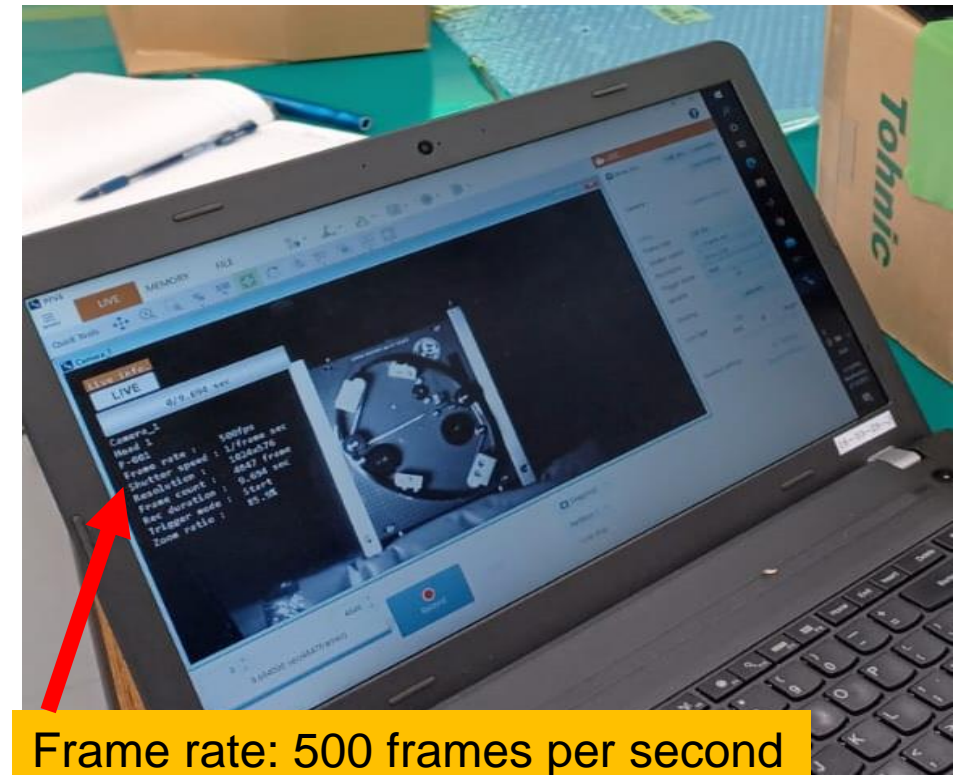
Antenna Deployment: Taken with High Speed Camera

Trial #	Orientation	Deployment Result	Remark
Trial 1	Vertical	success	
Trial 2	Vertical	success	
Trial 3	Horizontal	Success	
Trial 4	Horizontal	success	
Trial 5	Horizontal	Failed	Antenna was tightly tied

- To increase the height of the antenna guides so that the fishing string will have more margin of passing under the antenna elements
- Do antenna deployment under vacuum conditions using thermal vacuum chamber

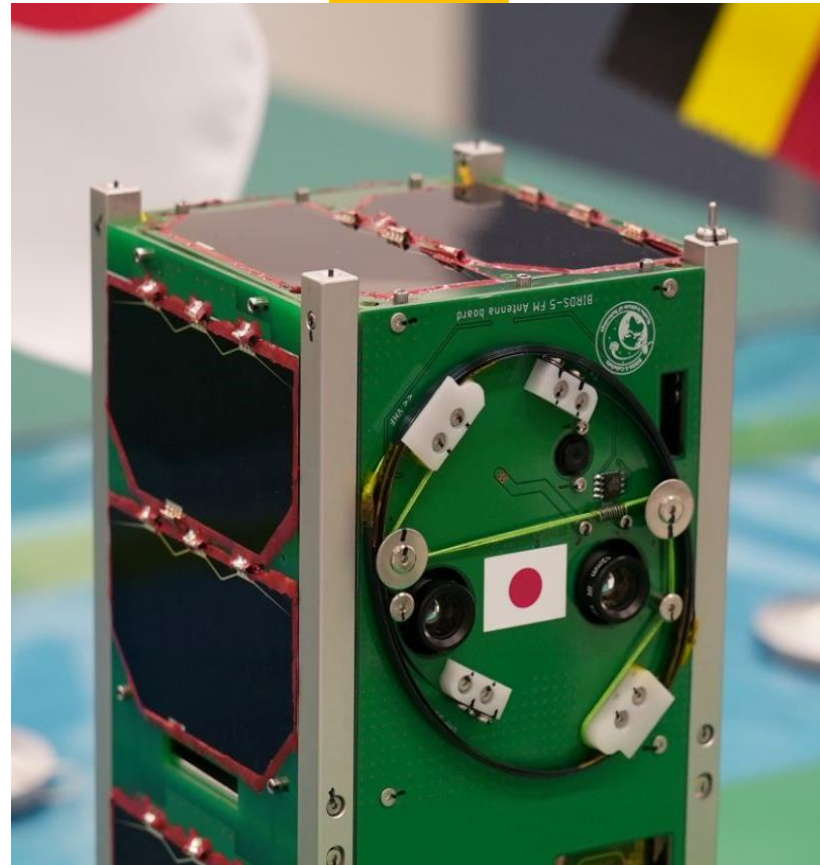
TAKA

E. Antenna deployment was physically broken

- **Unlikely**- judged from delivery to JAXA

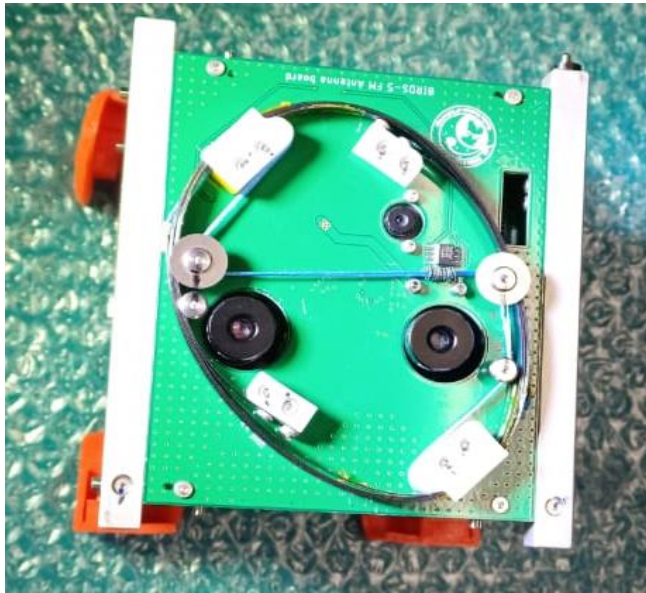
Folded antenna

Signal Power (dBm)	CASE1: Gain (dBi) (Small Partial Deployment)		CASE1: Gain (dBi) (High Partial Deployment)		CASE2: Gain dBi (Full Deployment)		Case 3: Gain (dBi) Folded	
	E-Plane	H-Plane	E-Plane	H-Plane	E-plane	H-Plane	E-plane	H-Plane
PTXlow &Att:39dB)	-36.10	-32.49	-28.09	-24.08	1.41	2.13		
PTXhigh (&Att:39dB)	-36.85	-32.25	-28.65	-23.65	1.44	2.25		
CW (19dBm)							-42.8	-45.38

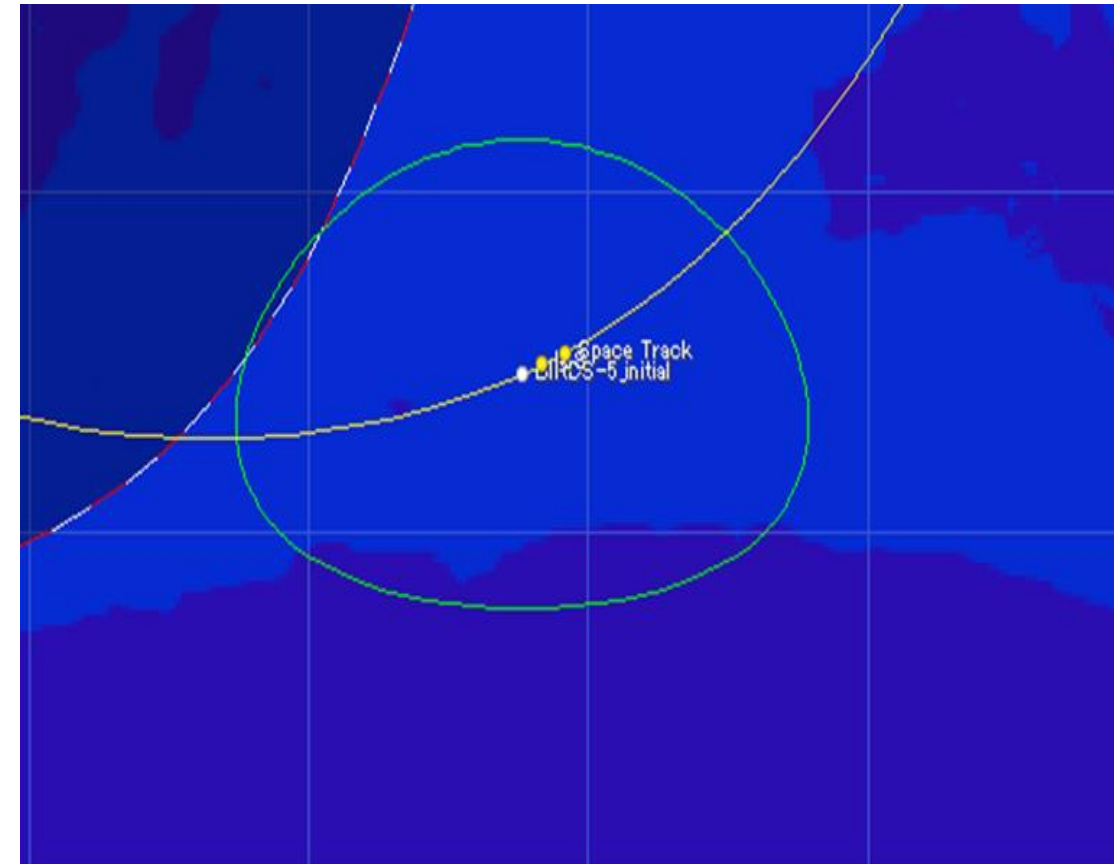
Satellite position in orbit after deployment.

TLE differences

- Initially NORAD vs ISS vs JAXA TLEs
 - Very small difference
- Hence **unlikely**
